# PV Panel and PV Inverter Damages Caused by Combination of Edge Delamination, Water Penetration, and High String Voltage in Moderate Climate

**Abstract**—There exist over 2 GW of photovoltaic (PV) systems in the Czech Republic, exposed to moderate continental climate. Although there exist many PV modules defects, thanks to the generally the same production year 2009, only some of them are usual at systems installed in Czech Republic. This work shows delamination failures that are frequent in moderate climate conditions. Special account is taken into edge delamination defect and its possible propagation in modules of standard construction. Combined PV panel and PV inverter failure is caused by edge delamination with water penetration and high string voltage. The electric discharge channel is created between the string of solar panels and the grounded PV panel frames. The result of the discharge channel created because of edge delamination is inverter switch-OFF and few months later total destruction of the inverter because of protective relay damage. The number of combined PV panel and PV inverter failures is increasing substantially after ninth year of operation of PV panels in m

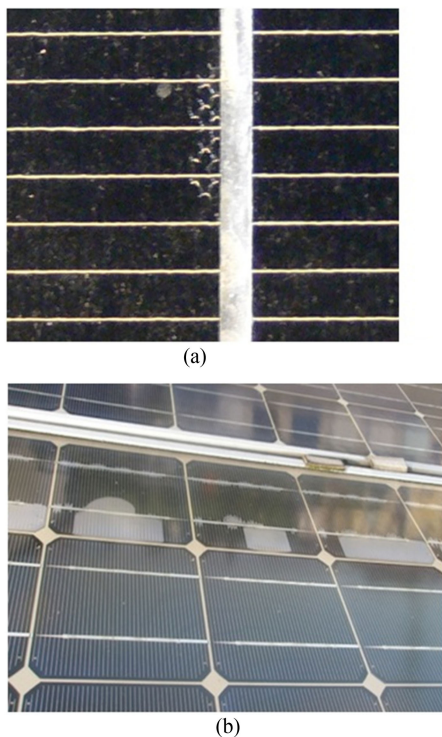
Fig. 1. Delamination between the front cover glass and encapsulant. (a) Early state. (b) Massive delamination.

For the fourth type of delamination (see Fig. 1), bubbles behind the cover glass are observable, in the case of textured glass then the “glass opacity” occurs. In the case of subsequent moisture penetration into the system, the gradual water ingress toward the cells comes because of the hygroscopic properties of EVA and consequently also the gradual decrease of the insulation resistance occurs, resulting in degradation of the structure because of electrolysis.

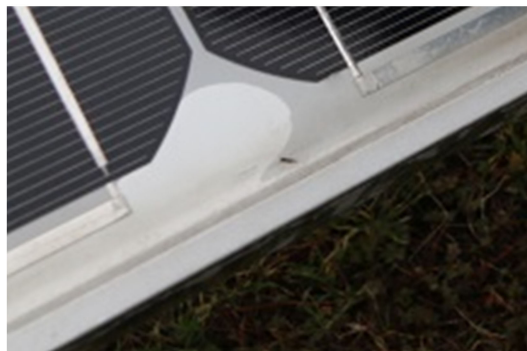
Fig. 2. Edge delamination.

In the fourth type delamination slot, which typically occurs at the edge of PV laminate (see Figs. 2 and 3), water is regularly penetrating. The pure water is not very conductive, but namely at glass/EVA PV laminates the acetic acid is always present [5]. The mixture of water and acetic acid is more conductive. The critical delamination discharge channel is created when water is penetrating in delamination area between the PV panel string and the grounded PV panel frame. The result of the critical delamination failure is inverter switch-OFF and later total destruction of the inverter because of protective relay damage. The breakthrough between the grounded PV panel frame and the internal solar cell bus-bar with system voltage up to 500–800 VDC is usual. The

Additional sealing of the PV panel frames by siloxane gel can reduce the number of combined PV panel and PV inverter very substantially. Several inverters with late switch on effect were selected and their frames were sealed by transparent polysiloxane gel. Late switch-ON effect was eliminated completely (see Table II).

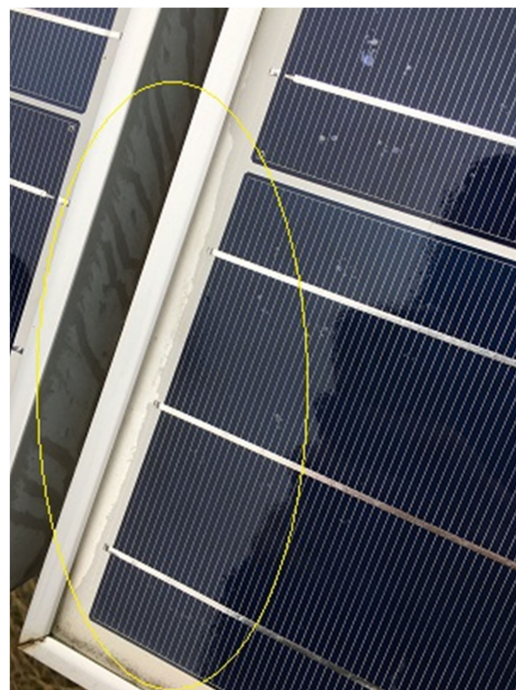
Fig. 3. Edge delamination.

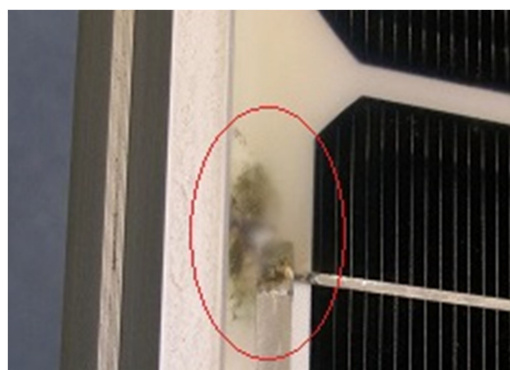
Fig. 4. Discharge channel between string bus bar and frame.

typical discharge channel is clearly visible (see Figs. 4 and 5). In this case, the PV panels are irreversibly damaged (destroyed). The destroyed PV panel is not producing any power and it causes inverter switch-OFF because of low Risol.

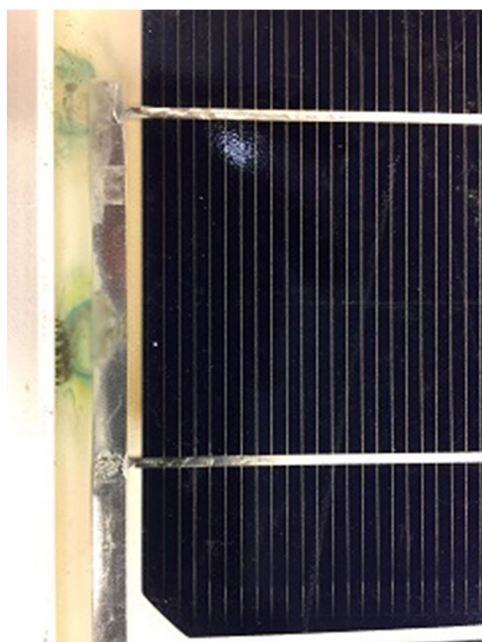
Fig. 5. Detail of another discharge channel.

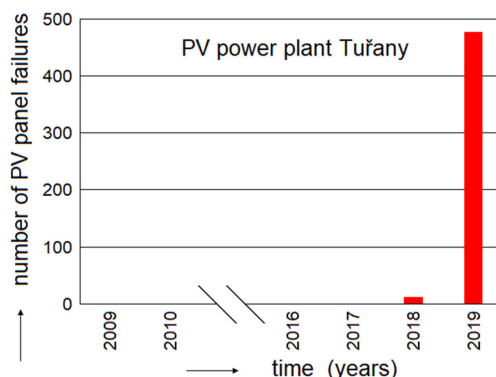
Fig. 6. Annual number of PV panel failures at Turany location.

about all PV panels and inverters (see Table I). Till ninth year after installation, no breakthroughs were detected. The electric breakthroughs were detected at 0.3% of PV panels ten years after installation. After 11 years, 1% of PV panels were destroyed by breakthrough (see Figs. 6–8).

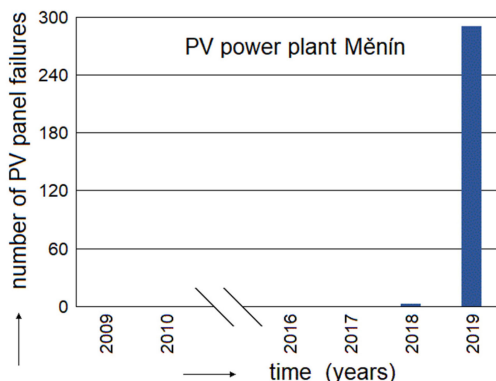
Fig. 7. Annual number of PV panel failures at Menin location.

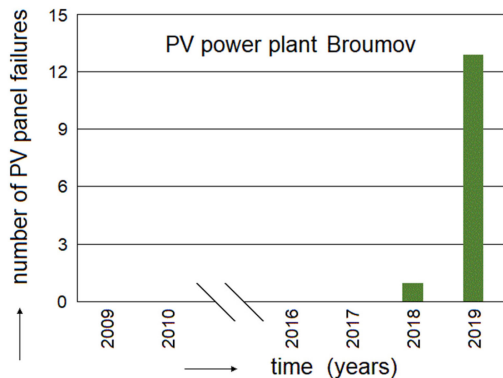
Fig. 8. Annual number of PV panel failures at Broumov location.

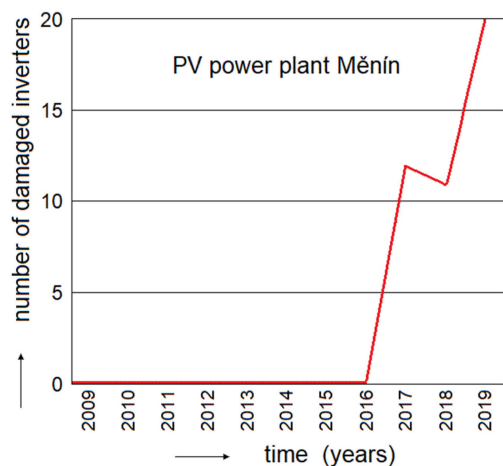
Unfortunately, the single panel electric breakthrough is usually, within few months, destroying the inverter that is more expensive than the PV panel itself. The inverter usually has protection circuit monitoring the isolation resistance Risol but at frequent discharges between the PV string and the grounded PV panel frame, the protection circuit is destroyed as well as the complete inverter (see Figs. 9 and 10).

Fig. 9. Annual number of inverter failures at Menin location.

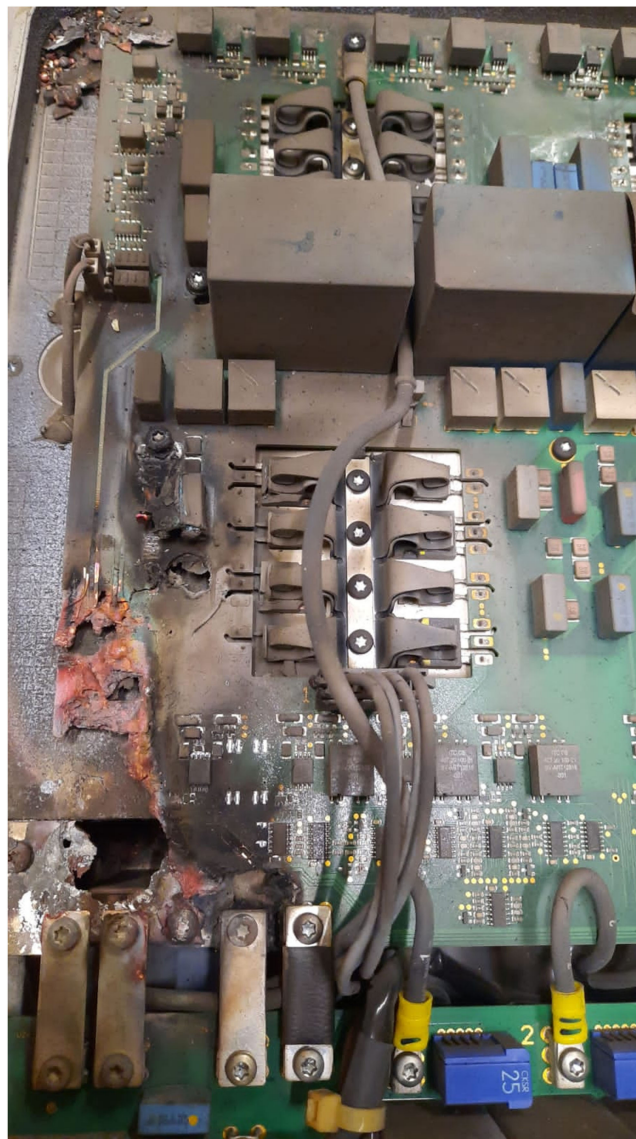
Fig. 10. Destroyed inverter SMA.
