Analysis and Treatment of an Overheated Ablated Fault on the Pole Shoe Surface of a Large Tubular Hydro-Generator

ABSTRACT Aimed at a new kind of overheated ablated fault on the pole shoe surface of a large tubular hydro-generator, based on the real site characteristics of the fault with combination of a physical field analysis, this paper reveals the occurrence mechanism of such faults from operational conditions, generator structure, material characteristics, and so on. On the basis of the results, the fault treatment and the generator improvement strategy are proposed. In addition, the treatment method has been applied to a faulty generator, and it successfully eliminating the fault. The research is of great significance for restraining the loss and heat of poles in large tubular hydro-generators as well as improving the safety and reliability of the operation of generators and power grids.

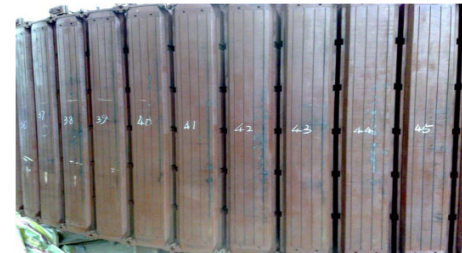
(a)Overheated ablated magnetic poles(a faulty generator)

First, the overheated traces are distributed in the shallow surface area of the pole shoe core, and the overheating propagation direction is from the surface of the pole shoe core to its interior.

Second, the surface area of the pole shoe core is seriously overheated and ablated, even looking bluish because of overheating.

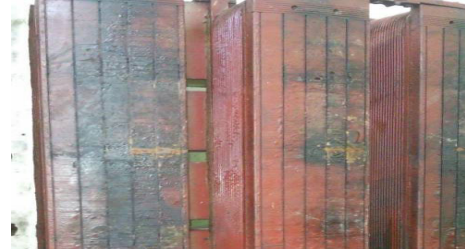
(b)Overheated ablated magnetic poles(a faulty generator in another hydropower station)

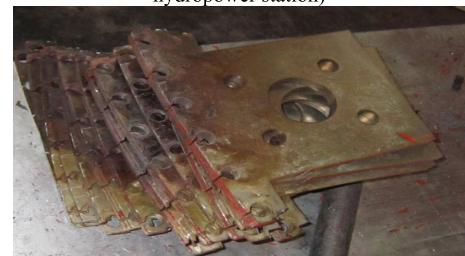
(c)Overheated ablated magnetic pole lamination

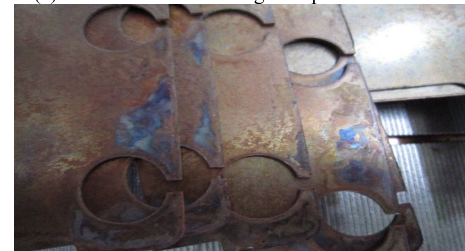
(d)Bluish traces due to overheating on the pole lamination in the downstream region

pole shoe iron core. Moreover, the overheated area in the upstream area is more serious than that in the downstream area.

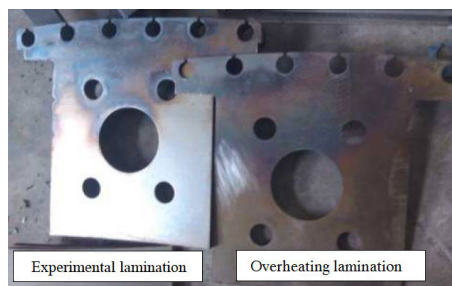
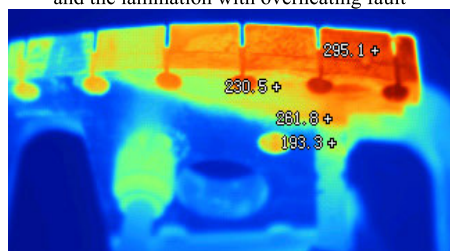
FIGURE 2. Simulation test of the overheated fault temperature by heating the pole lamination with the baking gun.

(a) The comparison between the test lamination heated by the baking gun and the lamination with overheating fault

(b) Infrared temperature spectrum of the heated lamination

First, we heated the surface of the pole shoe with the open fire of a baking gun, simulated the high temperature and heat transfer process of the pole shoe surface, and observed the discoloration of the paint film and the lamination. Then, we used a thermocouple and an infrared thermal imager to measure the temperature of the overheated position. The measurement results showed that the highest temperature at the overheated position was not lower than 295 °C, as shown in Fig. 2.

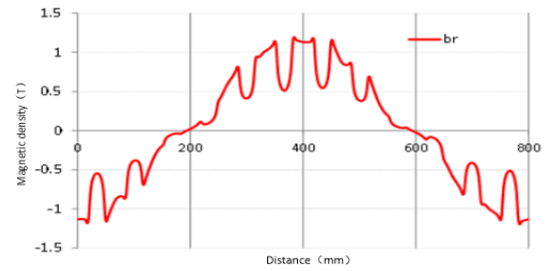
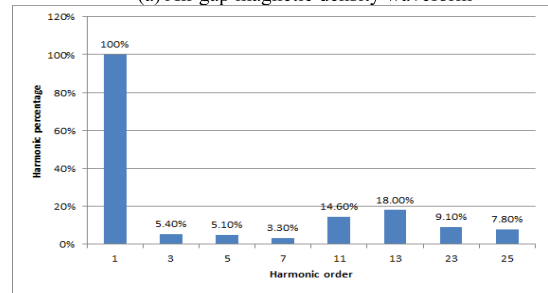
FIGURE 4. The air gap magnetic density waveform and harmonic spectrum of the faulty generator.

The results of the above calculation show that the tooth harmonic content of the air gap magnetic field of the faulty generator is relatively high. However, according to our experience of generator design and manufacturing, we find that most of the tubular hydro-generators have this problem, but, not all tubular hydro-generators have such a serious overheating phenomenon on the surface of their pole shoe. Therefore, it can be concluded that the high harmonic content of the air gap magnetic field is not the primary reason for such faults.

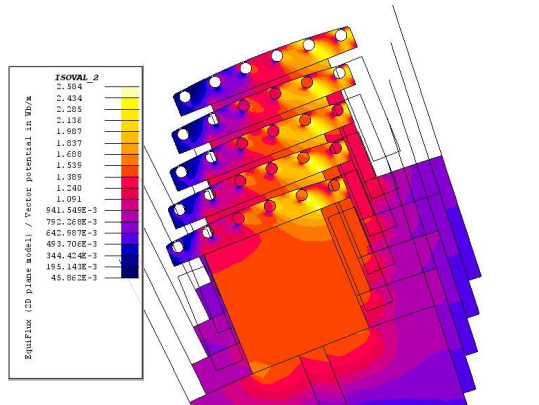
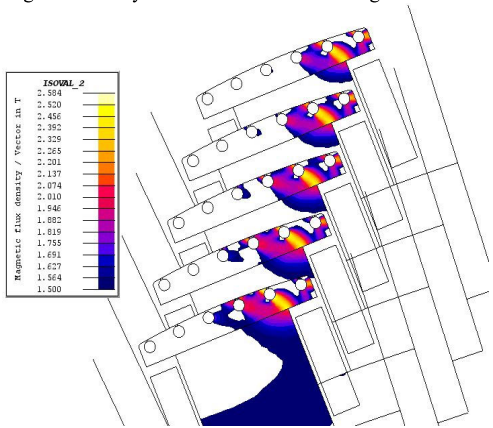
FIGURE 6. Magnetic density of the pole increases along the axial direction due to the stator slot skewed structure.

In addition, the calculation results of the generator’s magnetic field distribution also confirm this point, which is, when the stator slot skewed structure is adopted, the magnetic density of the rotor increases along the axial direction. Moreover, not only the magnetic density at the upstream end is significantly larger than that at the downstream end but also the area of the high magnetic density at the upstream end is significantly larger than that at the downstream end, as shown in Fig. 6.

First, the iron loss of the pole shoe is larger than that in the case of the stator slot no skewed structure. Second, it will increase this iron loss along the axial length of the pole. Thus, the heat of the pole shoe surface at the upstream end is significantly more than that at the downstream end. This resulted in the following failure phenomena:the overheating traces are distributed in the shallow area of the pole shoe core. And the overheating in the upstream area is significantly more than that in the downstream area.

From the above analysis, it can be concluded that the stator slot skewed structure should be the main cause of the fault.

(a)The magnetic density of the rotor increases along the axial direction

(b)The area of the high magnetic density at the upstream end is significantly larger than that at the downstream end

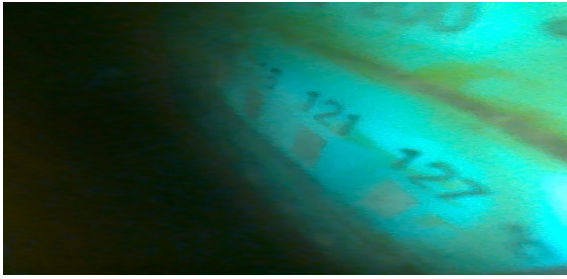
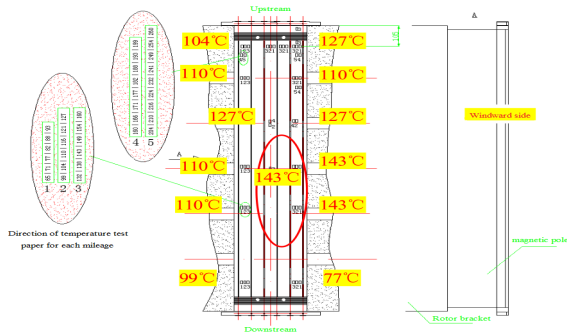
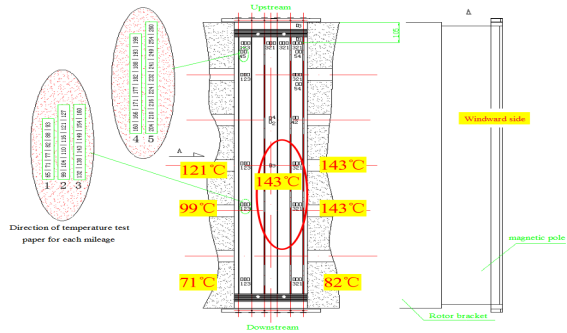
FIGURE 10. Test paper temperature measurement results of the pole shoe after the improvement.

(a) The discoloration of the test paper at some positions observed by the endoscope

From June 2016 (completion of improvement) to October 2016, the generator was symmetrically operated at full load for 100 days. Then, it was stopped, and the rotor was lifted out. The discoloration of the temperature measuring test paper on the surface of the pole shoe showed no signs of overheating or ablation. The relevant basic operation parameters are detailed in Table 9, and the relevant temperature measurement results are shown in Fig.10.
