Electrical-Mechanical Model of Electrical Breakdown of Epoxy-Impregnated-Paper Insulated Tubular Busbar With Bubble Defects

XIANG REN¹, LING RUAN¹, HAIYUN JIN², AND GUANJUN ZHANG², (Member, IEEE)

¹Electric Power Research Institute, State Grid Hubei Electric Power Company Ltd., Wuhan 430077, China

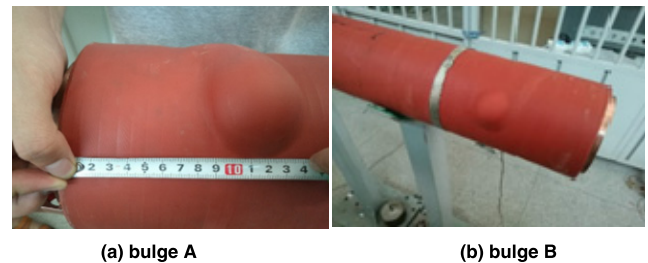
After electrical damage of 126.5h, the insulation failure of the sample was broken down, and a bulge was generated under the outer jacket layers at both ends, as shown in Fig.3.

Among them, the bulge A is far from the grounding wire, the center of the bulge is about 100mm~120mm from the copper conductor, the shape is like oval, the diameter is 60mm and 110mm, the expansion degree of the bulge is different, away from the center point, the expansion degree is reduced; the bulge B is near to the ground wire, the center of the bulge is about 120mm~140mm from the copper conductor, the shape is close to a sphere, and the diameter is about 56mm. The gas in the drum was collected and analyzed by gas chromatography, and the result is shown in Fig.4.

FIGURE 3. External bulge after sample insulation failure.

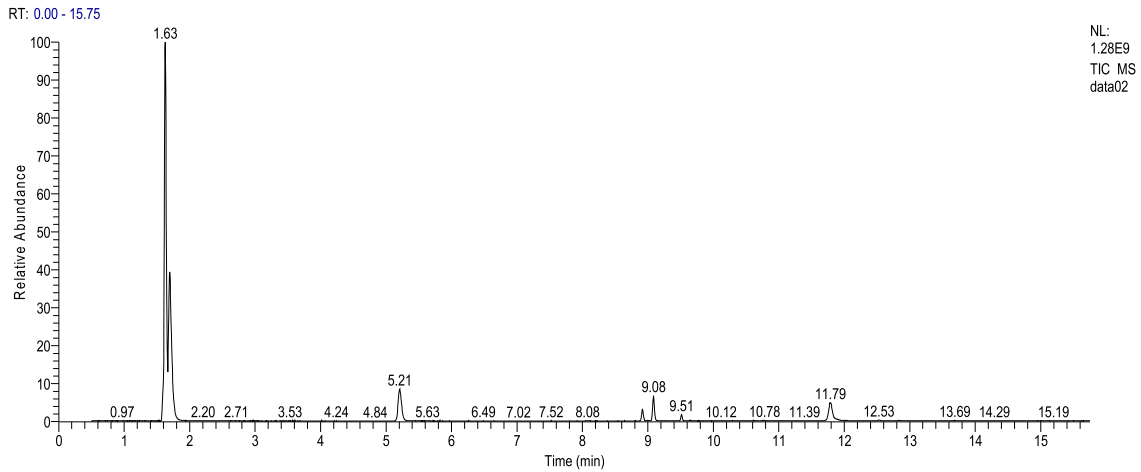
As shown in Figure 4, the outer sleeve is not damaged while the main insulation layer is seriously carbonized in the breakdown. The gas in the bulges can only come from the main insulation since it has formed as a strong tightly

solid. According to the analysis report, the first peak of the gas released from the sample is O_2 ; the second peak group is short-chain hydrocarbons containing carbon-carbon double bonds; the third peak group corresponds to xylene (C_8H_{10}); the fourth peak group corresponds to nonanes; the fifth peak group is aromatic hydrocarbon molecules.

The gas chromatography results can determine that the evolved gas is the decomposition product of the epoxy resin composite material in the sample insulation.

FIGURE 4. The gas chromatogram of escape gas.

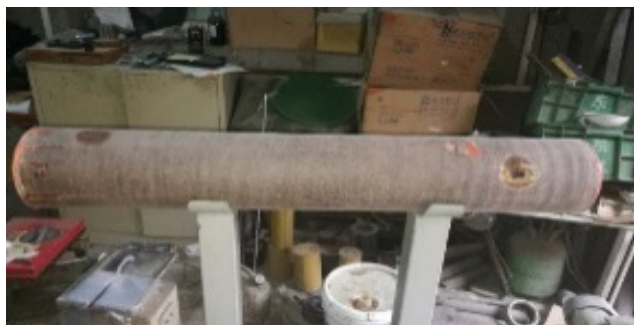
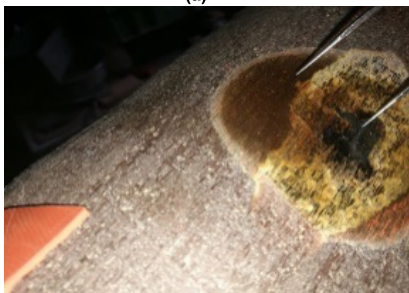
After collecting and analyzing the escaping gas, the outer sheath of the sample was dissected for better observation of the main insulation. It can be seen from Fig. 6 that there are two breakdown points on the sample insulation layer, which correspond to the bulge positions. According to our dissection of the experimental sample after breakdown, no penetrating breakdown has formed in the location of both the bubble A and B. The outer part of the insulation of bubble A, about 2.2mm of penetration depth from the breakdown point, has been carbonized seriously. It is quite different with that of bubble B. The inner part of bubble B has been carbonized seriously and the penetration depth is about 4.1mm.

The insulation material is carbonized, the closer to the center point at the breakdown point, the more obvious the carbonization trace, and the color is much darker, the material at the center point has been burnt black. The insulating material structure around the breakdown point becomes loose and brittle, all of which proves that the epoxy resin material has been destroyed and decomposed.

FIGURE 6. Appearance inspection of main insulation.

The crack propagation mode in Fig. 6 is a typical material instability failure. The reason is that the gas pressure in the pores exceeds the critical value of the fracture toughness of the bubble wall material under the action of partial discharge. The Fracture Toughness Critical Value (K_{IC}) is a material mechanical strength concept that characterizes the impedance value displayed when an unstable fracture occurs in a sample or component with cracks or crack-like defects.

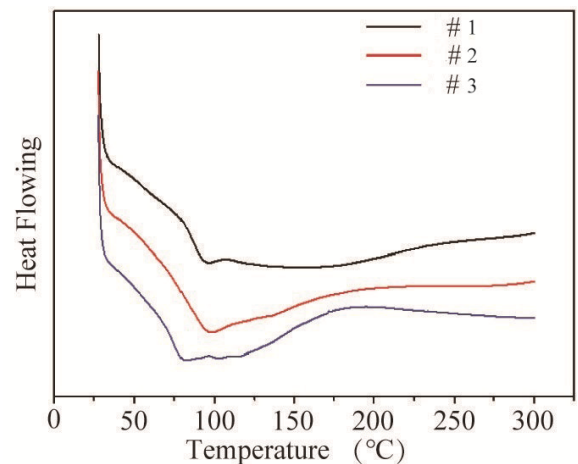
FIGURE 7. DSC curves of three points (#1, #2, #3).

According to Fig.7, the glass transition temperature (T_g) can be calculated, 87.99°C for #1, 95.94°C for #2 and 77.72 for #3. T_g of #2 is a little higher than that of #1 because of the high temperature during the breakdown. The transient high temperature, but not high enough, could make the epoxy resin undergo further curing. But the T_g of #3 decrease a lot since the material there has been carbonized seriously.

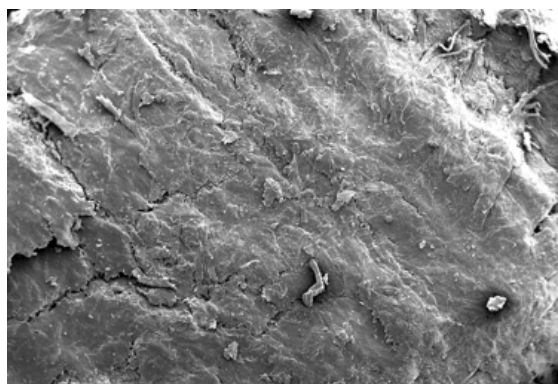
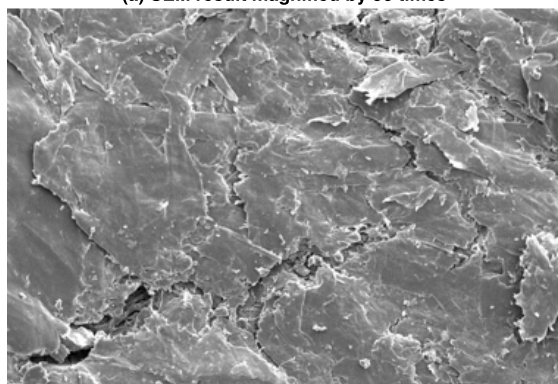
Subsequently, a sample of epoxy insulating material that has not been fully carbonized, insulation of #2, is extracted and observed using a scanning electron microscope (SEM) to verify the explanation above. The result is shown in Fig.8, while that of #3 is shown in Fig. 9.

It can be found from Fig. 7 to Fig. 9 that the epoxy resin in the insulating material near the breakdown point has been carbonized seriously and became loose and brittle, many cracks have appeared, and the crack morphology exhibits obvious mechanical damage. The epoxy material in this paper is a brittle material, which has certain similarity with ceramic

FIGURE 8. SEM results of epoxy insulation of #2.

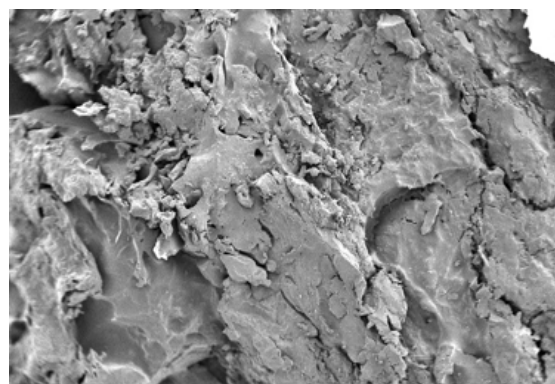
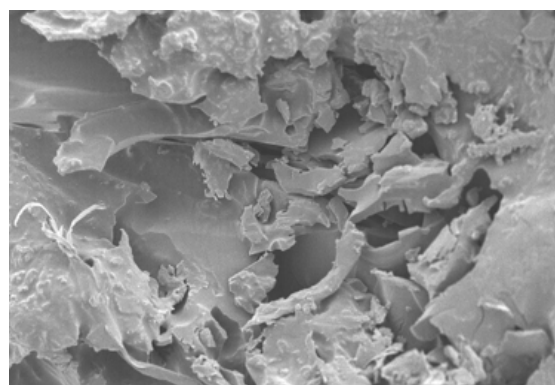
FIGURE 9. SEM results of epoxy insulation of #3.

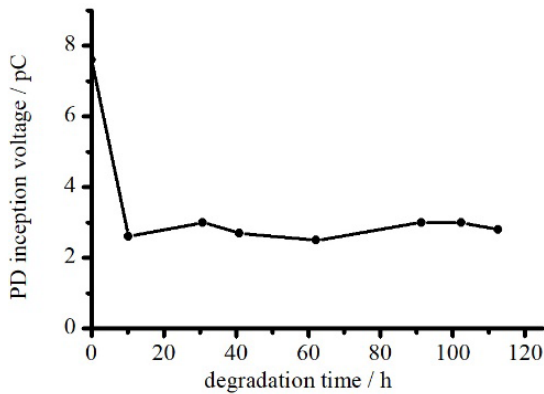
The inception value of the partial discharge starting voltage U_i of the sample is 7.6kV (the factory test value is 7kV). After a short period of electrical degradation (about 10h), the partial discharge starting voltage U_i of the sample quickly decreases to 2.6kV. During the subsequent electrical degradation, the partial discharge inception voltage U_i of the sample has been maintained at this level, fluctuating in the range of 2.5kV~3kV.

FIGURE 10. Sample partial discharge inception voltage U_i as a function of degradation time.

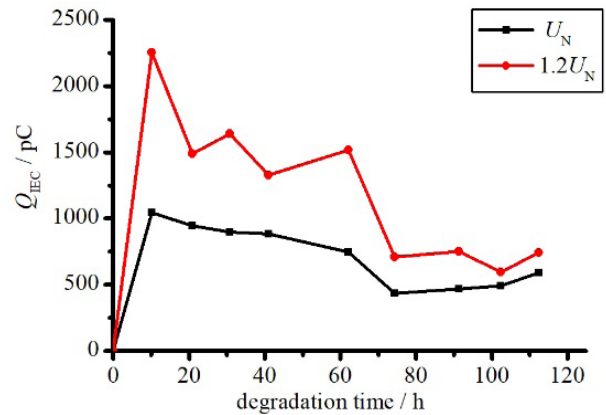
It can be concluded from Fig. 11 that before the electrical breakdown, there is no partial discharge ($<2pC$) in the sample at the U_N and $1.2 U_N$ voltage; and after a short period of

FIGURE 11. U_N , $1.2 U_N$ measured voltage partial discharge amount Q_{IEC} as a function of degradation time.

electrical degradation (about 10h), the partial discharge of the sample Q_{IEC} increase rapidly, The value of Q_{IEC} is 1045pC at the U_N voltage, and the value is 2253pC at the $1.2 U_N$ voltage; henceforth, as the degradation time increases, the partial discharge amount Q_{IEC} of the sample gradually decreases, and eventually maintains at a relatively stable level. Before the electrical breakdown of the sample, namely the destruction time is 112h, the Q_{IEC} value of the sample is about 600pC at the U_N voltage, and the Q_{IEC} value of the sample is about 700pC at the $1.2 U_N$ voltage. The partial discharge amount of samples under different voltages during electrical breakdown shows the system difference. At the $1.2U_N$ voltage, the Q_{IEC} value of the sample is higher than that at the U_N voltage. The gap reaches the top (about 1200pC,) at the initial stage of degradation. With the destruction develops, the gap gradually reduced to the range of 200pC~300pC.
