Interpretation of Turn-to-Turn Insulation Fault by Dissolved Gas Analysis

Dongjin Kweon and Yonghyun Kim

Korea Electric Power Corporation
105 Munji-Ro, Yuseong-Gu, Daejeon 34056, Korea

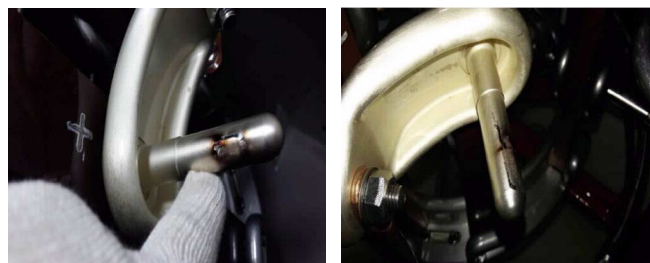
The transformer was de-energized, and the external parts of winding, core, clamps, bolts, bushing lead, support wood, and OLTC tap lead were inspected, but thermal or carbonization marks were not found. Local thermal traces were also not found in core. However, as shown in the results of the evaluation of the fault, arc traces at OLTC tap selector contacts were found (Figure 2). Therefore, OLTC tap selector contacts were replaced. The fault in the transformer was considered to have been repaired, and voltage applied on the transformer in February 2016. After applying the load, DGA results measured every month from March 2016 were all normal.

(a) + Tap

(b) - Tap

Figure 2. Arc traces at OLTC tap selector.

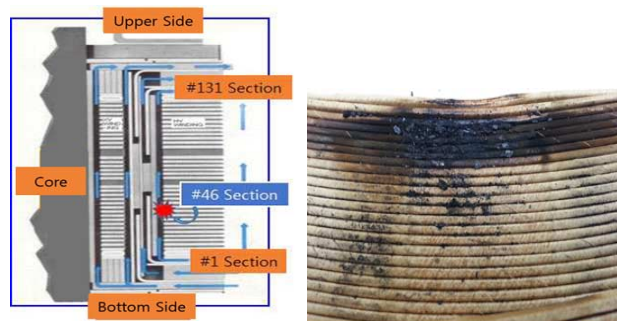
Therefore, paper begins to deteriorate due to partial discharge at first, and C_2H_4 and CH_4 are generated by the local overheating of paper by partial discharge. As paper deterioration and amount of partial discharges increase, C_2H_4 and CH_4 increase, and H_2 occurs due to partial discharge. Therefore, the transformer in this study can be interpreted as being in a state in which partial discharge in turn-to-turn winding increase considerably due to the progress of paper deterioration. However, arc discharge did not progress because C_2H_2 was low. That was, this transformer corresponds to the typical example of the degradation of turn-to-turn insulation fault classified in Section 2.A.

As a result of the fault thus evaluated, the transformer was considered dangerous to operate. The transformer was moved to the factory in December 2016 and disassembled clamp, core and winding to identify the fault in January 2017. After disassembling windings, carbonized traces were found between sections #46 and #47 in the bottom of the medium-voltage winding, as shown in Figure 3, possibly due to discharges but more likely to the hot spot T3.

Figure 3. Carbonization in the medium-voltage winding.
