# Modeling and Assessment of Lightning Hazards to Humans in Heritage Monuments in India and Sri Lanka

**ABSTRACT** Lightning is one of the inevitable disastrous phenomena which in addition to damaging tall edifices, might also consequently endanger humans due to lightning-human interactions. This research focuses on analyzing lightning hazards to humans in the vicinity of heritage monuments in India and Sri Lanka. Five monuments which include three giant stupas namely Ruwanweliseya, Jethawanaramaya and Abayagiriya from Sri Lanka and two large temples namely Brihadishvara Temple and Gangaikonda Cholapuram from India have been chosen for investigation. Lightning-human interaction mechanisms namely direct strike, side flash, aborted upward leader, step and touch voltages have been investigated for the most onerous scenario on humans in the vicinity of the monuments. Firstly, the electro-geometric model as stipulated in standards has been implemented to ascertain the effectiveness of lightning protection to the structures. Subsequently, the study has been extended to the computation of step and touch voltages utilizing lightning current and electrostatic models based on Finite Element

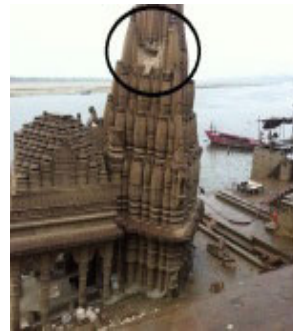
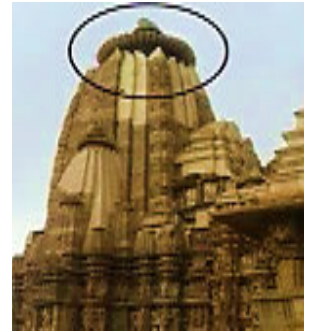
**FIGURE 4.** Lightning Damages (a) Rathneswar Mahadeshwar Temple and (b) Jagadambika Temple in 2016 and 2015 respectively.

<b>Jameswar Temple Nilamdhhab Temple</b>	Bhubaneswar, India, 2016 Khandapada – Odisha, India, 2016	<ol style="list-style-type: none"> <li>1. Deep crack developed on the walls of temple wall and a chunk of its ornate exterior hung precariously.</li> <li>2. A portion of the temple suffered significant damages.</li> <li>3. The crown of the temple had developed crack and the flag on top of the shrine was blown away under the impact of the strike</li> </ol>
<b>Basilica of Bom</b>	Goa, India, 2015	<ol style="list-style-type: none"> <li>1. Lightning struck the structure and damaged a pillar and tiles on the roof.</li> <li>2. Lightning struck a pillar, which broke and felled a shower of stones and associated structure.</li> </ol>
<b>Se Cathedral</b>	Goa, India, 2014	<ol style="list-style-type: none"> <li>1. Lightning destroyed one of the gables, while also damaging roof tiles at several places.</li> <li>2. The false ceiling of one of the halls near the priests' residence had been partly damaged.</li> </ol>

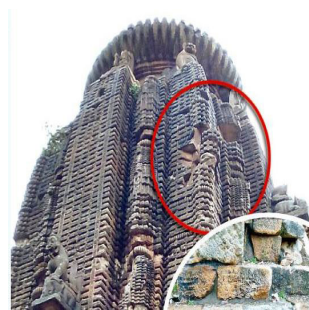
**FIGURE 5.** Lightning Strikes in (a) Jameswar and (b) Nilamdhhab Temples respectively.

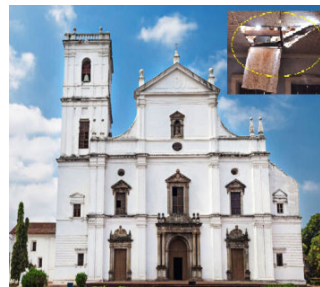
**FIGURE 6.** Damaged roof and gables due to lightning strikes in Se Cathedral and Basilica of Bom Churches at Goa during 2015 and 2016 respectively.

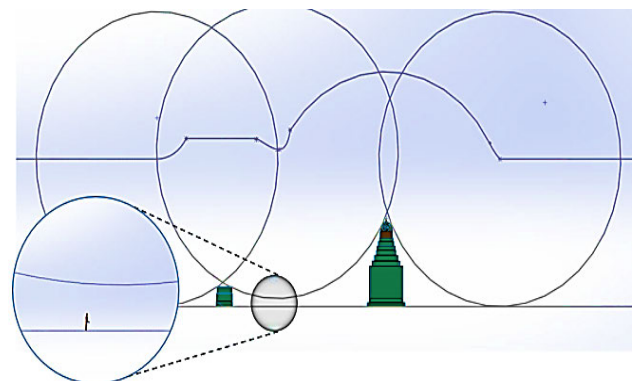
FIGURE 25. Loci of LPZ and vulnerable points of human in Gangaikonda Cholapuram.

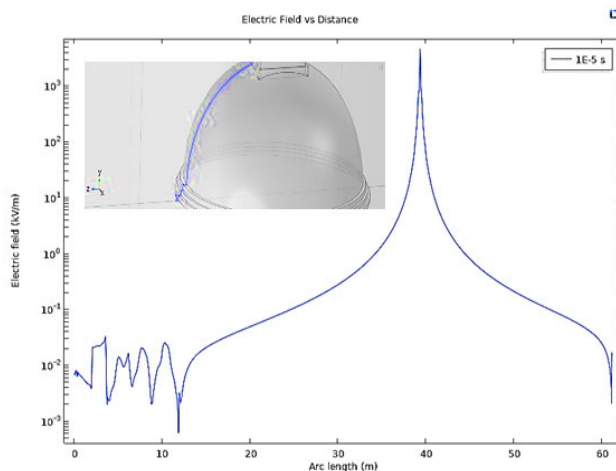
FIGURE 28. Electric field distribution during lightning strike on Ruwanweliseya.

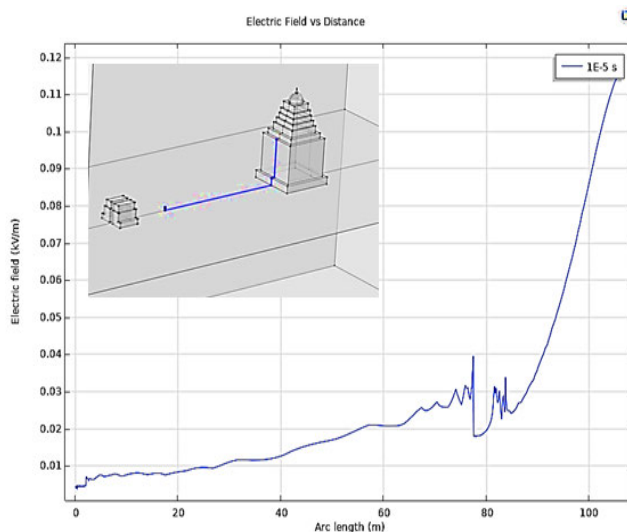
FIGURE 29. Electric field distribution during strike on Gangaikonda Cholapuram.

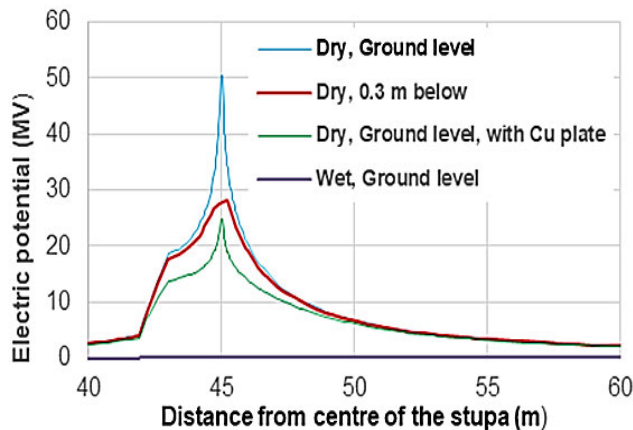
**FIGURE 30.** Potential distribution along the ground plane in the vicinity of the grounding rod: distance measured from the center of the stupa with earth rod located 45 m away from the center.

In order to estimate step voltages, electric potential distribution in the vicinity of the grounding rod during lightning discharge through the LPS has been computed by means of COMSOL simulation. The tested lightning current is 30 kA of a wave shape of 10/350  $\mu$ s. Since the depth of the installed grounding rod from the floor is also important for the step voltage, two cases i.e. rod on the ground surface and rod 0.3 m below the ground surface are also considered. In addition to that dry and wet conditions are simulated by adjusting the conductivity of soil and brick according to Table 5. As a special case, a copper plate buried at a 3 m depth and connected to the grounding rod is also considered. Fig. 30 shows potential distribution along the ground level in the vicinity of the rod for few selected cases: (a) dry conditions with rod on ground level, (b) dry conditions with rod 0.3 m below ground level, (c) dry conditions with rod on ground level along with a plate and (d) wet conditions with rod on ground level. As expected, higher ground potential rise occurs near the earth rod for all the cases. Highest potential rise can be observed when the rod is at the ground level under dry conditions, i.e. case (a). Installation of the rod 0.3 m below the ground level reduces the maximum ground potential rise almost by 50%.

However, its effect is limited to the region near the rod. In case of a plate, significant reduction of the potential can be seen over a wide area surrounding the rod. The potential during wet condition is much lesser (<1% of case (a)) than under dry conditions. By considering these observations two worst cases: (a) and (b) have been selected for further analysis. Table 7 summarizes the estimated step voltages of the pilgrim (devotee) when standing near the monument for the two cases. Two distances between legs i.e. standard 1 m distance and typical 0.3 m distance are considered.
