Investigation on the Physical Properties of Varistors According to Temperature

ABSTRACT This study aims to determine the basic physical properties of varistor, which is a protective element in a surge protection device (SPD) used to prevent damage to electric and electronic equipment due to lightning. To do this, we conducted tests of insulation resistance, leakage current, heating characteristics, accelerated aging, impulse current, and operating duty according to temperature. To measure insulation resistance and leakage current, an S1-1568 insulation resistance tester was used. To measure the temperature rise according to a change in the external environment, a convection oven was employed. For the impulse current test, a surge current generator of a direct lightning strike, which was designed and manufactured according to the IEEE and UL standards, was used. We verified that the leakage current increased and the insulation resistance decreased as the voltage and outside temperature were applied to the varistor. This meant that heating and deterioration accelerated due to the leakage current, depending on the place where the SPD was applied. Heat accumulation due to constant hea

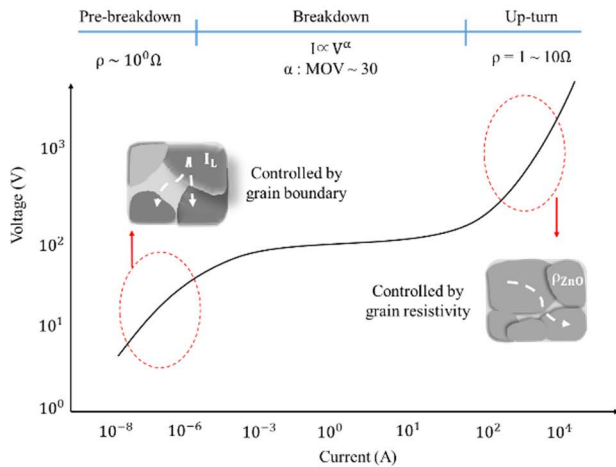
FIGURE 1. Characteristics of varistor: voltage-current curve.

absorbing an overvoltage. As shown in Figure 1, the varistor current–voltage characteristic has a symmetric curve, which shows decreasing resistance when the voltage increases. The current–voltage characteristic graph has pre-breakdown, breakdown, and upturn regions [23]. The current–voltage characteristic is linearly exhibited in the pre-breakdown region, which is a low-voltage region. In the breakdown region, resistance rapidly drops, and a large current flows when an abnormal voltage is applied, resulting in a nonlinear shape of voltage and current.

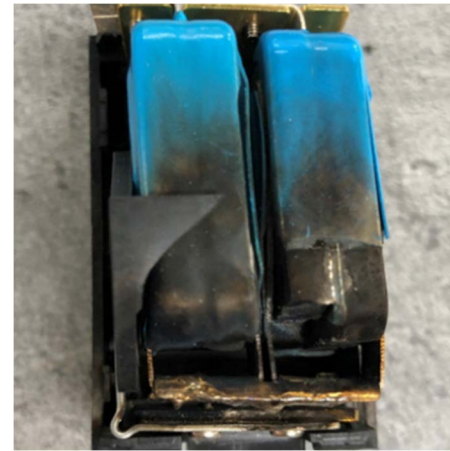
FIGURE 2. SPD damaged by thermal runaway.

than 20% of the initial value set in the related test sequence. If this value is exceeded, we determine that a lifetime is degraded. If a varistor whose lifetime is degraded is used continuously, the leakage current increases inside the varistor, thereby generating heat accumulation due to heating and leading to an explosion or fire caused by a thermal runaway if the heat dissipation limit is exceeded. Figure 2 shows the SPD damaged by the thermal runaway caused by the generation of leakage current.

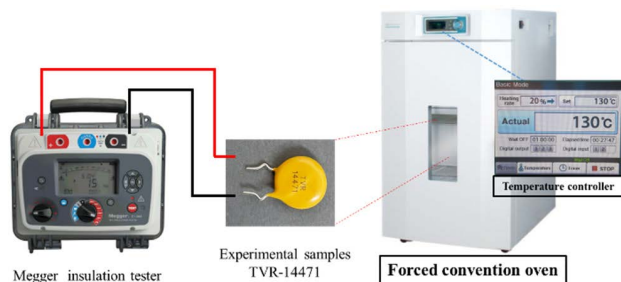
FIGURE 3. Hardware composition.

To analyze the fundamental physical properties of the varistor, changes in leakage current and insulation resistance were measured using an S1 - 1568 insulation resistance tester. The selected test sample of the varistor was TVR - 14471 manufactured by Thinking Electronic Industrial Co. Ltd, considering the insulation resistance tester and the experimental circumstances. To measure the temperature change, a K - type thermocouple was attached. Table 1 presents the fundamental characteristics of the varistor. Figure 3 shows the hardware composition of the leakage current and insulation resistance tests according to the temperature changes and voltage. To check the changes in leakage current and insulation resistance according to the applied voltage rise at room temperature, a voltage was sequentially applied for one minute using an insulation resistance tester. The changes in leakage currents and insulation resistance were measured by applying a voltage to the varistor while increasing the temperature sequentially using a convection oven. In the experiment, the same specimens were used to calculate the average value after three repeated measurement.

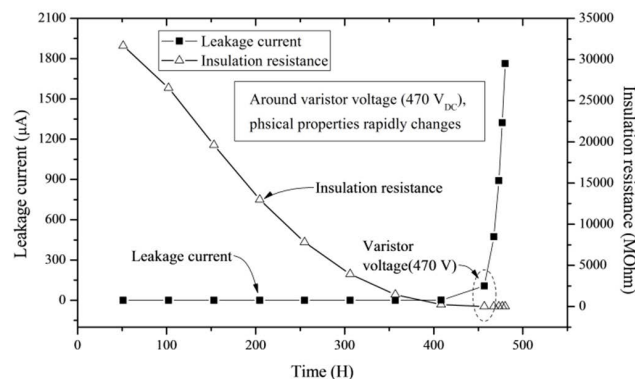
FIGURE 4. Current-voltage characteristics of TVR-14471-D.

Figure 4 shows the measurement results of changes in leakage current and insulation resistance of the varistor by sequentially applying a voltage from 50 V to 477 V_{DC} at room temperature. In the pre-breakdown region below around 400 V_{DC} , resistance decreases as voltage increases, whereas the leakage current increases proportionally. In the breakdown and upturn regions above around 470 V_{DC} ,

insulation resistance rapidly decreases, and the leakage current rapidly increases. This verifies that the varistor changes from an insulation status to a short circuit.

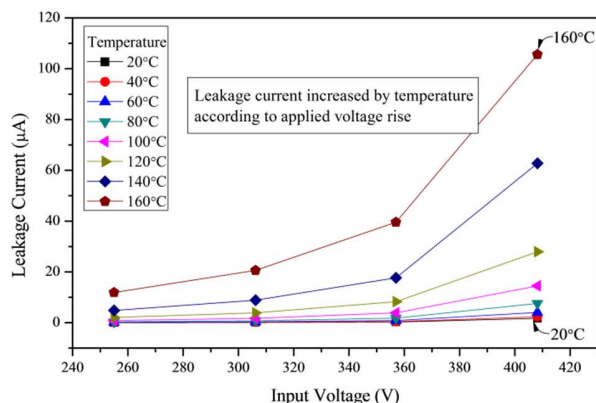
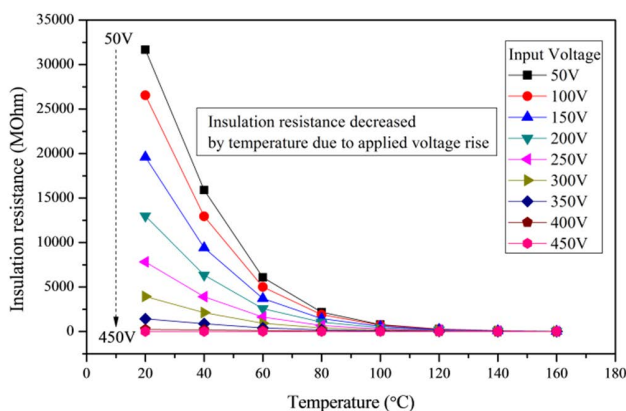
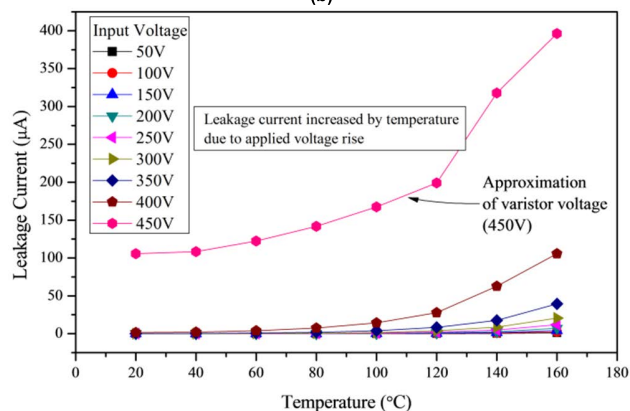
FIGURE 5. Physical properties of TVR-14471-D with increasing temperature (a) Leakage current by temperature according to applied voltage rise (b) Insulation resistance change according to temperature rise (c) Leakage current change due to temperature rise.

Figure 5 shows the physical properties of the varistor according to changes in the external environment (temperature rise). A varistor was installed inside the convection oven, and the temperature increased from 20°C to 40°C, 60°C, 80°C, 100°C, 120°C, 140°C, and 160°C to measure changes in leakage current and insulation resistance accordingly. Figures 5(a) and (b) verify an increase in leakage current and a reduction in the insulator’s resistance as the temperature increases. In addition, it verifies decreasing insulation resistance of the varistor at 100°C or higher, and even below the V_N, a leakage current gradually increased. This indicates that heating may be generated by a leakage current, but deterioration may also be accelerated, depending on the place where the SPD is applied. Figure 5(c) verifies that a change in the leakage current does not occur rapidly as the temperature increases in voltage below 400 V_{DC}, whereas the leakage current increases rapidly as the voltage is closer

to the V_N because the change in leakage current sensitively reacts to temperature.

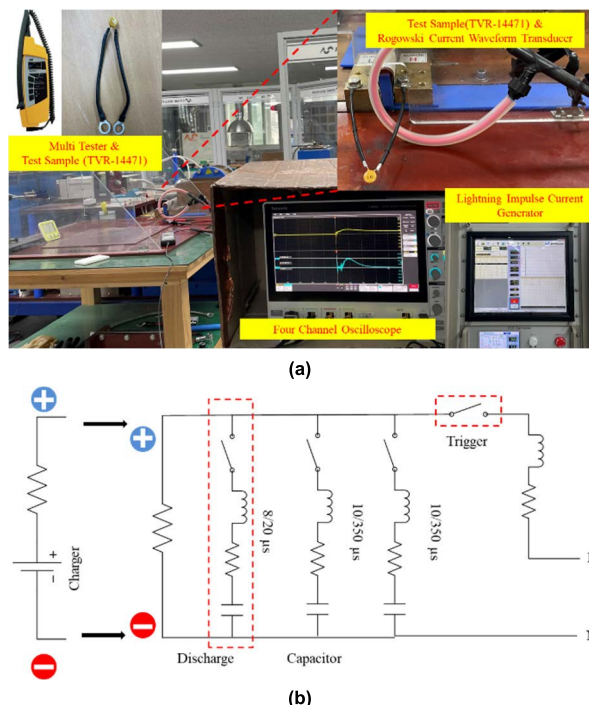
FIGURE 7. Configuration of lightning impulse current test (a) Composition of operating duty test (b) Circuit diagram of lightning impulse current generator.

A direct lightning strike surge current generator, which was designed and manufactured according to Institute of Electrical and Electronics Engineers (IEEE) and Underwriters' Laboratories (UL) standards, was employed. Figure 7 shows the configuration of the experimental device and circuit diagram [28], [29], [30], [32], [33], [34]. The maximum U_c (300 V_{rms}) of the varistor TVR - 14471 was applied. Based on the maximum I_n value (4.5 kA) of the 8/20 μs current waveform, a test was conducted by dividing the current into 7 kA, 4 kA, and 2 kA in the Type II SPD test using a lightning impulse current generator and a high-voltage differential probe. As shown in Figure 7, a four-channel oscilloscope (MSO44) was used to measure the current, and then the current was converted to be calculated using a Rogowski current waveform transducer (CWT1500B).

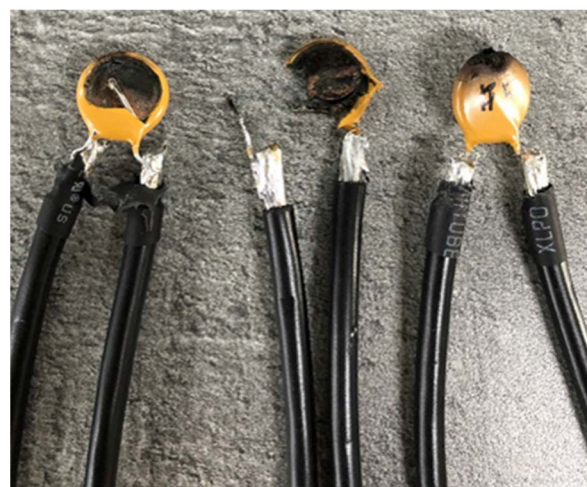
FIGURE 8. Photographs of the test samples.

was evaluated according to Table 4 - General pass criteria of the design test in IEC 61643 - 11. The varistor samples, where 5 times, 10 times, and 15 times of 1.85 kA were applied, had minimal changes in V_N , and the operating duty test was determined to have passed. This meant that the maximum surge current of the TVR - 14471 sample was 4.5 kA, which did not have a significant impact on performance (Survey of Damage Cases for Surge Protective Devices Installed Electrical Communication Systems and Analysis of Degradation Diagnosis Method). As the number of applying 3.85 kA increased, the change in V_N also increased (6 - 12 V), and it was determined to have failed in the operating duty test. The varistor sample, where 7.1 kA was applied once, showed a significant decrease from 491 V to 436 V. It was determined to have failed in the operating duty test, which was expected, as there was a performance difference according to a change in the physical properties. Figure 8 shows the sample used in the test, where twice of 7.1 kA and 12 times of 3.94 kA were applied. The sample was damaged during the test. Since the max surge current was 4.5 kA, it exceeded the performance limit. Thus, we determined that the grain boundary of the varistor was damaged.

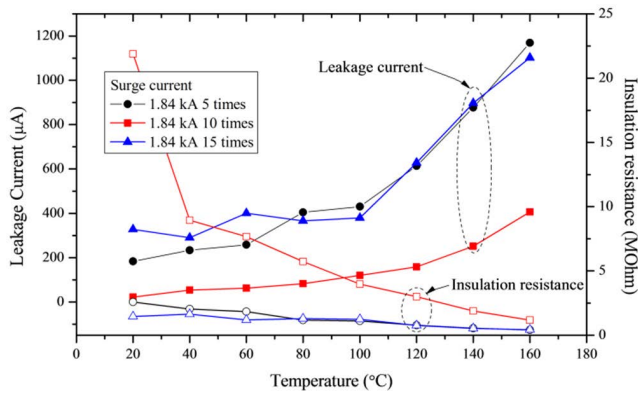
FIGURE 10. Leakage current and insulation resistance characteristics by the number of surge currents applied (1.84 kA).

Figure 10 shows the changes according to the number of 2 kA lightning impulse currents (5, 10, and 15 times) applied caused by changes in abnormal voltage and external

environments in the operating duty test. It shows a trend of an increase in leakage current and decreases in insulation resistance as the temperature rises, but no significant difference is shown in changes as the number of currents applied increases. Since the maximum surge current of TVR - 14471 was 4.5 kA, the change in V_N was minimal, as presented in Table 2. Accordingly, the damage to grain boundary of the varistor was insignificant and did not have a significant impact on performance degradation.

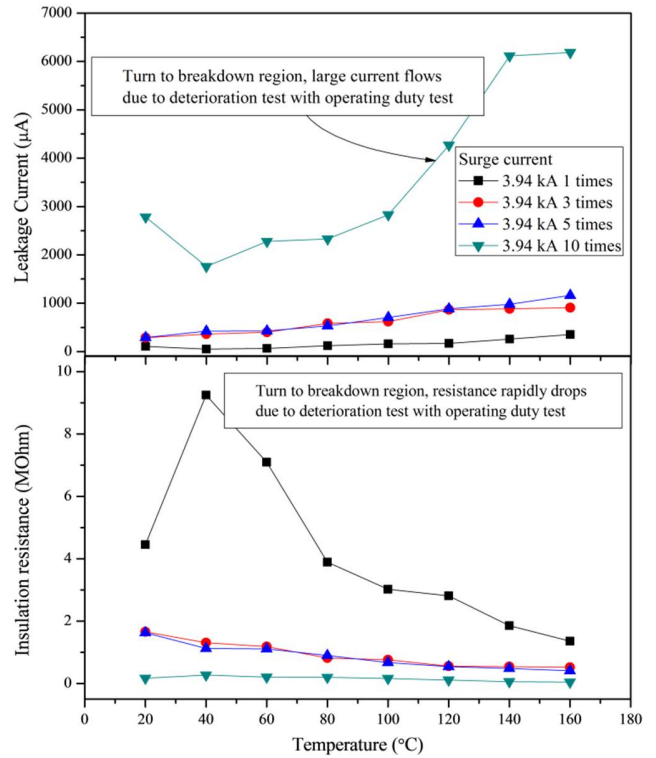
FIGURE 11. Leakage current and insulation resistance characteristics by the number of surge currents applied (3.94 kA).

Figure 11 shows the changes according to the number of 4 kA lightning impulse currents applied caused by changes in abnormal voltage and external environments in the operating duty test. The varistor that absorbed a 4 kA surge was determined to have failed in the operating duty test. The deterioration test using an insulation resistance tester shows a trend of increasing leakage current and decreasing insulation resistance as the temperature rises. As the number of surge currents applied increased, the leakage current of the sample where the surge current was applied increased, and insulation resistance decreased. In particular, changes in the leakage current and insulation resistance of a sample where 3.94 kA was applied 10 times were around 30% of a sample where 3.94 kA was applied once. Considering that the maximum surge current of TVR - 14471 was 4.5 kA, the change in V_N was found to be around 6 - 2 V, as presented in Table 2, which was determined as a section that affected the performance degradation due to the occurrence of damage to the grain boundary of the varistor.

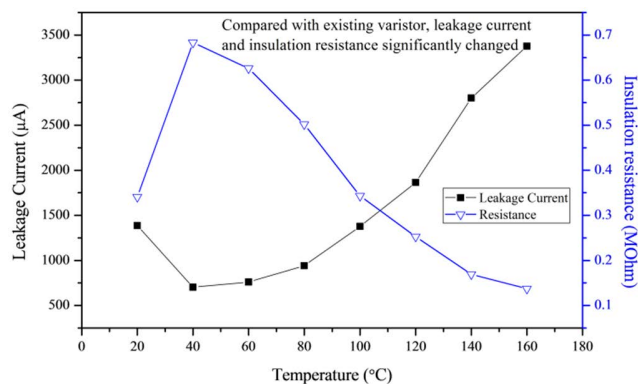
FIGURE 12. Leakage current and insulation resistance characteristics by the number of surge currents applied (7.1 kA).

Figure 12 shows the changes according to the number of 7 kA lightning impulse currents applied caused by changes in abnormal voltage and external environments in the operating duty test. The varistor was determined to have failed in the operating duty test. It was damaged in most tests when an impulse current was applied. The deterioration test results through the changes in V_N applied and external environments exhibited a trend of increasing leakage current and decreasing insulation resistance as the temperature rose. This showed a

significantly increased leakage current compared to that of the existing varistor. Considering that the maximum surge current of TVR - 14471 was 4.5 kA, the grain boundary inside the varistor was destroyed when a 7 kA surge current was applied, which led to damage. This meant that when an impulse current that exceeded the maximum surge current was applied, the change in V_N deepened as the number of currents applied increased. Accordingly, it caused damage to the grain boundary of the varistor, resulting in changes in the physical properties and performance degradation, which may lead to destruction and damage to the varistor.
