Analysis and Treatment of an Overheated Ablated Fault on the Pole Shoe Surface of a Large Tubular Hydro-Generator

ABSTRACT Aimed at a new kind of overheated ablated fault on the pole shoe surface of a large tubular hydro-generator, based on the real site characteristics of the fault with combination of a physical field analysis, this paper reveals the occurrence mechanism of such faults from operational conditions, generator structure, material characteristics, and so on. On the basis of the results, the fault treatment and the generator improvement strategy are proposed. In addition, the treatment method has been applied to a faulty generator, and it successfully eliminating the fault. The research is of great significance for restraining the loss and heat of poles in large tubular hydro-generators as well as improving the safety and reliability of the operation of generators and power grids.

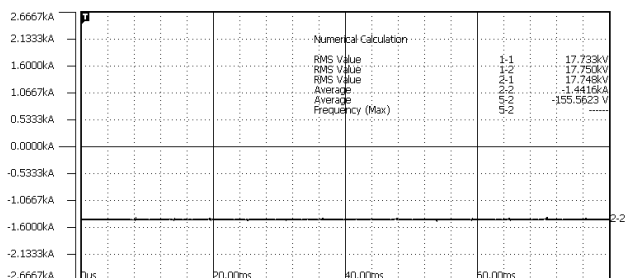
FIGURE 5. Oscillogram of the excitation current.

In the SCR excitation system, the excitation voltage has a high harmonic frequency of 300 Hz. However, due to the strong role of the rotor inductance, it can be regarded as a low-pass filter, where most of the harmonics are filtered out. Thus, basically, the excitation current will only have DC components, and there will not be any obvious harmonic components, not to mention cause such serious faults. This can be confirmed in the recorded spectrum of the excitation current. Fig. 5 is an oscillogram of an excitation current of a generator in a power station.

In addition, even if we step back to assume that the pole heating is caused by the excitation current harmonic, the pole’s magnetic field will have the same change. That is, the loss and heat of pole will be uniform and not concentrated only on the pole shoe surface.

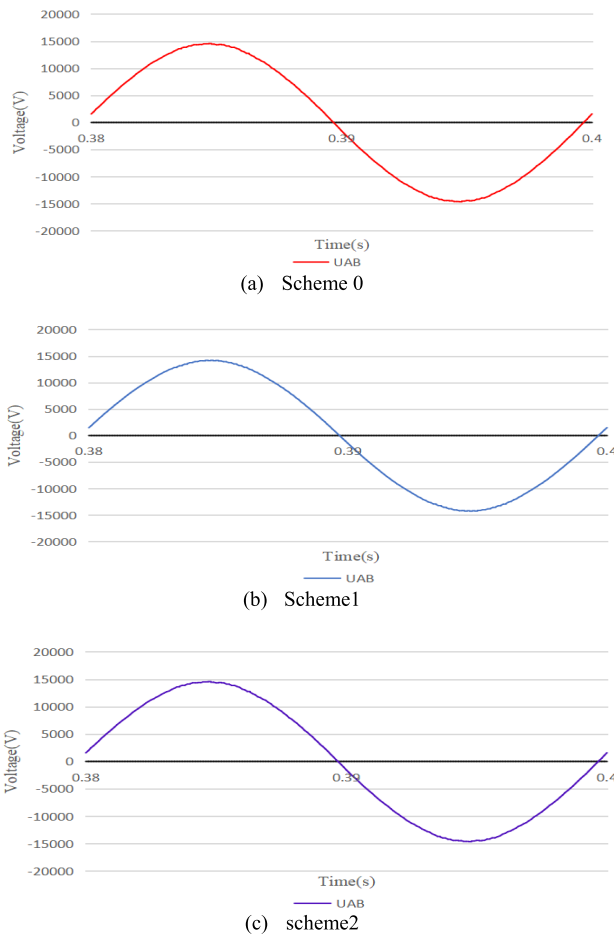
FIGURE 8. Comparison of the no-load voltage waveforms of different schemes.

The reason is that, in the aspect of the no-load voltage waveform optimization, for the generator whose number of slots per pole per phase is an integer, and when the structure of the stator slot skewed or the pole shoe and damper winding centerline shifting by $0.25t_1$ is separately adopted, the tooth harmonic of the no-load voltage can be weakened and the no-load voltage waveform can be optimized. However, if the above two structures are used at the same time, it is possible to make the effect of the waveform optimization more obvious, which is shown in Fig. 8. Therefore, the above two schemes can achieve a great no-load voltage waveform quality.

In the second scheme, not only the no-load voltage waveform is of high quality but also the core loss of the pole shoe is significantly suppressed, which is only 29% of that of scheme 0 (i.e. failure scheme). In addition, and the damper winding loss does not increase with respect to scheme 0. Therefore, this scheme will significantly reduce the heat in the pole shoe area.

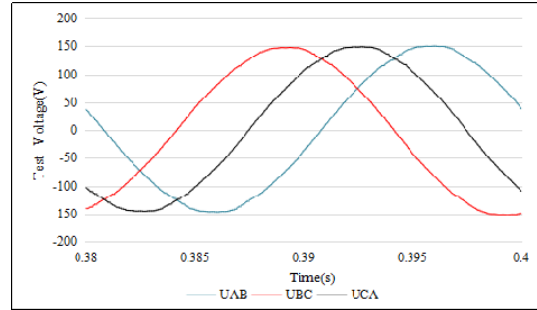
FIGURE 11. No-load voltage measurement waveform of the repaired generator.

At the same time, before the generator was connected to the grid, we also measured the no-load voltage waveform, as shown in Fig. 11. The relevant waveform quality parameters are provided in Table 10, and they show that the no-load voltage waveform quality is considerably good.

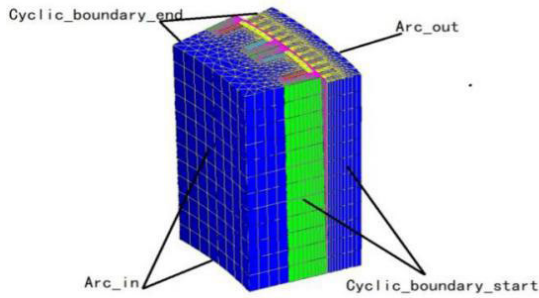
FIGURE 12. Problem regions and FE meshes of electromagnetic fields.

According to the periodicity of the generator's magnetic field, a pair of poles was chosen as the electromagnetic field calculation region. Based on the stator slot skewed structural design, the generator was divided into twelve equal slices along the axial direction as shown in Fig. 12.
