Development of a Concrete Floating and Delamination Detection System Using Infrared Thermography

Index Terms—Boosting, civil engineering, concrete, infrared surveillance, inspection, machine learning.

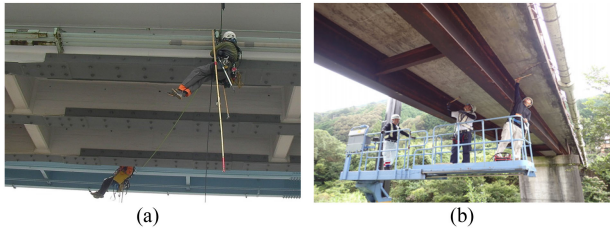
Fig. 1. Example of inspection using (a) rope access and (b) high-location work vehicle for bridge inspection.

to approach high up include, for instance, rope access [see Fig. 1(a)] or using a high-location work vehicle [see Fig. 1(b)]; however, these methods are costly and highly dangerous. Hence, there is a need for inspection methods that can be performed remotely from the ground and with less effort, and that can be applied to the entire structure with high precision. In Japan, as a part of CIM (construction information modeling/management), the utilization of information-based techniques such as image analysis technology, artificial intelligence (AI) technology, and cloud servers has been promoted. This study aims to use this framework to make the inspection of floating and delamination more efficient.

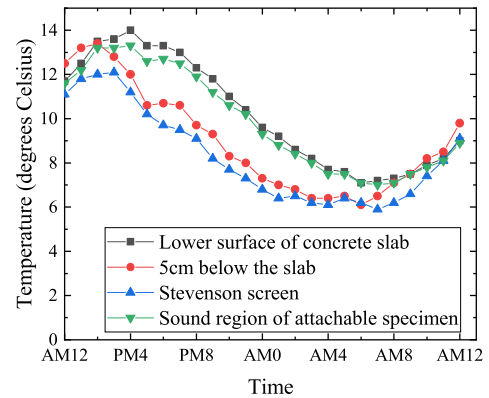
Fig. 7. Attachable specimen verification results.

shows the measurement results. The temperature of the lower surface of the concrete bridge slab and that of the sound area of the attachable specimen showed the same transition, indicating that the concrete bridge and attachable specimen were thermally integrated. After confirming that the concrete structure is in an appropriate thermal environment using the attachable specimen, internal damage can be detected from thermal images. In the next section, a method to select which of the detected temperature irregularities are due to floating or delamination by machine learning is presented.

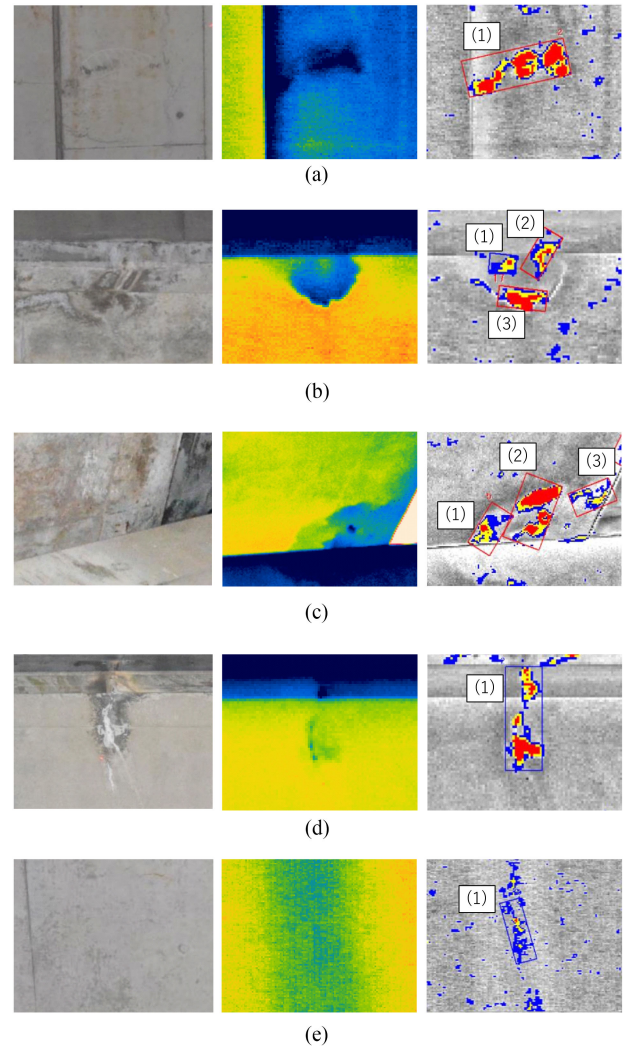
Fig. 11. Example of automatic detection results. From the left side, respectively, these are visual images, infrared images, and quadratized infrared images. The top three classification results are listed below each image. (a) Detection (1): Floating: 97.8%, Delamination: 1.2%, Free lime: 0.8%. (b) Detection (1): Free lime: 72.3%, Repair marks: 21.4%, Sound area: 6.3% Detection (2): Delamination: 82.1%, Free lime: 11.3%, Sound area: 6.1% Detection (3): Delamination: 91.3%, Free lime: 7.9%, Floating: 0.5%. (c) Detection (1): Repair marks: 41.2%, Delamination: 37.9%, Sound area: 21.0% Detection (2): Delamination: 88.0%, Free lime: 7.1%, Repair marks: 4.0% Detection (3): Delamination: 42.9%, Sound area: 39.4%, Repair marks: 17.9%. (d) Detection (1): Free lime: 72.4%, Delamination: 20.1%, Floating: 4.3%. (e) Detection (1): Sound area: 98.1%, Adhered slag: 1.1%, Repair marks: 0.8%.

Fig. 11 shows an example of the analysis results. From the left side, respectively, these are visual images, infrared images, and quadratized infrared images. **Fig. 11(a)** shows the result of detecting floating as the first rank. The infrared image clearly shows the existence of floating, and the detailed investigation showed that it existed. **Fig. 11(b)** shows a case where there

are three temperature irregularities represented by (1)–(3) in the image, where (1) was classified as free lime, and (2) and (3) as delamination. The results of the detailed investigation showed that all of these were correct. Fig. 11(c) also shows three temperature irregularities indicated as (1)–(3) in the image, and the delamination is classified as second, first, and first, respectively. According to the detailed investigation, delamination existed in all positions (1)–(3). In (1), the delamination was classified as second place, but the inspector was able to take appropriate action because it was clear from the visible image that the repair marks classified as the first place did not exist. Fig. 11(d) shows a case in which free lime is in first place, whereas Fig. 11(e) shows an example in which sound areas are in first place. Detailed investigations later proved that both results were correct. It is difficult for humans to classify these damage types from infrared images, indicating that the automatic detection method employing machine learning developed in this study works appropriately.

Future tasks are described as follows. This study dealt with floating and delamination of concrete, however, since civil engineering structures frequently use not only concrete but also steel members, we would like to link the developed method in this study to the detection of damage in steel members. For example, the authors have shown in [22]–[25] that corrosion and fatigue of steel members have a significant effect on the safety of structures, but an effective method to evaluate them from a distance has not been established, which is a topic that needs to be solved. Since corrosion and fatigue may affect the temperature distribution, our method using infrared images may be useful to detect them. In addition, currently, we are able to detect floating and delamination with 98.9% accuracy by including the second candidate, and 100% accuracy by including the third candidate; however, we would really like to detect them with high accuracy as the first candidate. For this purpose, it is still necessary to use the framework of deep learning, which automatically generates a large number of features, instead of manually determining the features as in this study. For this reason, we are currently collecting bridge inspection data in a wide variety of environments. In addition to this, we are also considering including visible images in the analysis. Considering that visible images also contain various types of information, we expect that simultaneous analysis of infrared and visible images will improve the accuracy and prevent errors such as (1) in Fig. 11(c).
