# Damage Characteristics and Microstructure Response of Steel Alloy Q235B Subjected to Simulated Lightning Currents

**ABSTRACT** This paper elucidates the damage characteristics, microstructure response and temperature rise of steel alloy Q235B suffered from lightning currents, which is the basis for lightning protection of oil tanks. Damage is inflicted in the designed Q235B specimens by using the multi-waveform multi-pulse impulse current generator to characterize the damage response induced by four typical lightning current components. The changes in the element composition and micro-hardness of Q235B are documented in the experiment. The microstructure changes in response to the temperature rise are analyzed by the proposed lightning-metal temperature rise model. The results reveal that, first, return stroke current with an amplitude of 201.2 kA leads to the largest damaged area of 3523.8 mm<sup>2</sup>. Continuing current in the stroke intervals with a charge transfer of 12.1 C results in the damaged area of 12.6 mm<sup>2</sup> and the damaged depth of 0.5 mm. Long continuing current after stroke with a charge transfer of 210.1 C leads to the deepest damaged depth of 3.0 mm.

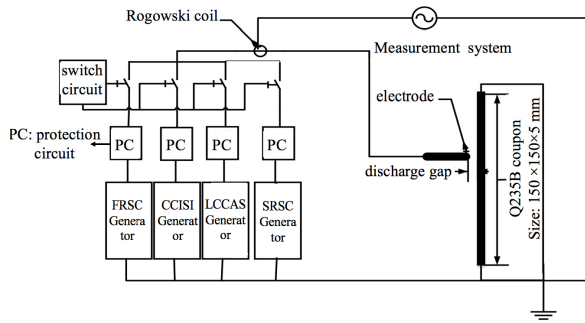
The Q235B coupons are designed into the cuboid of size 150 mm(length)  $\times$  150 mm(width)  $\times$  5 mm(height) to meet the shape requirements of the following material inspections. These coupons are set up vertically to reduce the impacts of gravity. In order to stabilize the arc root, four symmetric grounding connections are installed with coupon contacting area more than 1500  $\text{mm}^2$  to conduct lightning currents

symmetrically to the ground. Arc root shows moveless characteristics when the discharge distance between the electrode and Q235B coupon is shorter than 10 mm [16]. And the metal damage volume decreases with discharge distance increasing. Therefore, the discharge distance is fixed at 5 mm in the experiment. The schematic diagram of the lightning metal damage experiment is illustrated in Figure 2.

FIGURE 2. Schematic diagram of lightning metal damage experiment.

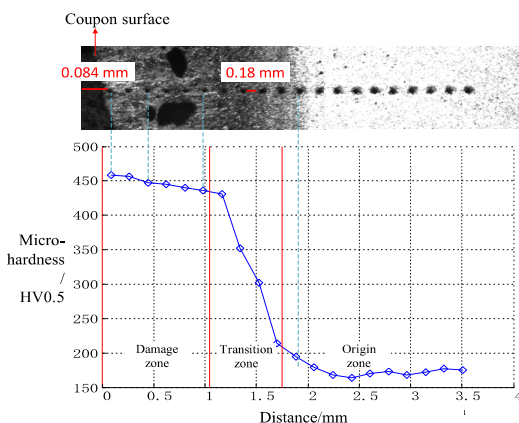
The average micro-hardness for the damage zone, transition zone, and origin zone are 450, 310, and 180 HV0.5, respectively, which are measured with 0.18 mm intervals and starting at the point 0.084 mm away from the coupon surface, as illustrated in Figure 8. The load of the probe is 0.5 kgf with duration 15.5 s setting in the ZHV30/zwickiLine hardness testing machine. It is concluded that the average micro-hardness of damage zone increases by 150 % compared with the origin zone. There exists an obvious gradient in the transition zone, of which the range could reach 250 HV0.5. This is because the micro-hardness of Martensite, Bainite, Pearlite, and Ferrite decreases in turn. The content of Martensite in damage zone is the highest and decreases along the three zones. Some Bainite appears in the interface of the damage zone and transition zone. Then the contents of Martensite decreases sharply, leading to the big gradient of micro-hardness in the transition zone.

FIGURE 8. Micro-hardness value along sample damaged depth.

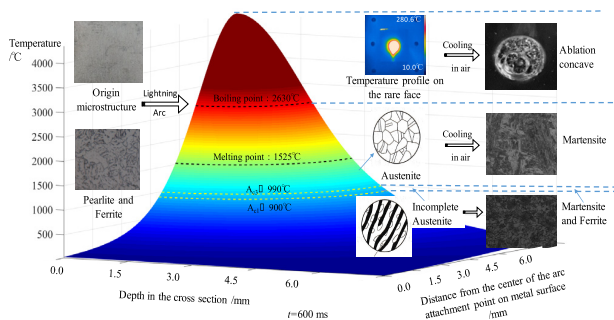
In Figure 9 and Figure 10,  $A_{c1}$  is the critical temperature of 900 °C for the Pearlite and Ferrite starting to transform into the Austenite.  $A_{c3}$  is the critical temperature of 990 °C

**FIGURE 10.** Corresponding analyses between metal temperature profile in cross-section and microstructure.

for the Pearlite and Ferrite finishing the transformation to the Austenite. The width between the temperature 900 °C and 990 °C is 0.1 mm at  $t = 600$  ms as illustrated in Figure 10, which matches the microstructure observation results in Figure 6.
