Detection and Characterization of Mechanical Impact Damage Within Multi-Layer Carbon Fiber Reinforced Polymer (CFRP) Laminate Using Passive Thermography

ABSTRACT With the increasing application of CFRP laminate, there is an 'urgent need for the rapid, visual, and non-intrusive method to 'detect mechanical impact damage. Passive thermography has been proven 'as a promising alternative to traditional nondestructive test technique by 'imaging the surface temperature difference of target with the advantages of 'real-time, non-intrusive, full-field, and visual 'results. Therefore, the aim of this paper is to 'characterize the impact damage types using passive thermography. To 'this goal, several specimens are subjected to impact test with 'different energies of 5, 10, 15, 20, '30, and 36 J and monitored by infrared camera. Then, active 'pulse thermography, SEM, and ultrasonic C-scanning are applied to 'detect the specimens respectively and the corresponding detection results 'are comparatively analyzed. On this basis, the impact damage 'types of CFRP are characterized. The obtained results show that 'different impact damage types occur under the different impact energies and 'can be ch

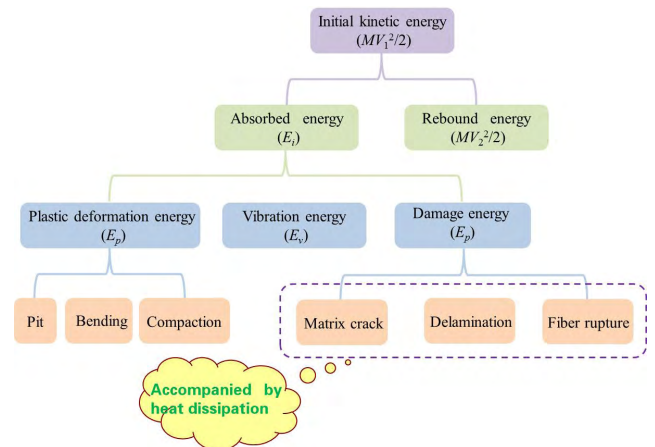
FIGURE 1. Energy conversion of specimen during impact event.

During the impact event, the energy conversion of specimen is outlined in Fig. 1. Suppose that the pendulum head hits the specimen with a certain velocity, V_1 , as a result, it is re-bounded by the specimen with another certain velocity, V_2 , which is less than V_1 . According to the energy balance equation proposed by Wang *et al.* [31] and Kang and Cheol [32] *et al.*, the loss kinetic energy, E_i , which is absorbed by the specimen, can be obtained as shown in Eq. (1).

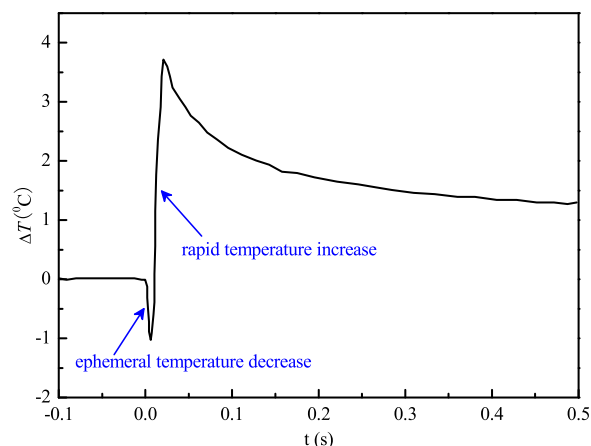
FIGURE 6. The ephemeral temperature decrease in the impact event in [23], [25], and [26].

phenomenon of ephemeral temperature decrease in this work but observed in [23], [25], and [26], as shown in Fig. 6. Meola and Carlomagno [25] explained that the ephemeral ΔT decrease phenomenon is present since the specimen surface reacts to the impact in an elastic manner (thermo-elastic effect) and the rapid ΔT increase phenomenon is due to the plastic reaction of specimen to impact event (thermo-plastic effect).

Compared with the ΔT curve in Fig. 6, the ΔT curve obtained in this work (in Fig. 5) only shows the rapid temperature increase phenomenon, not the ephemeral temperature decrease because the impact time is circa a few milliseconds while the gather frequency is set as 25 Hz, which is far slowly than that in [23], [25], and [26] of a few hundred hertz and leads to the loss of observation of the thermo-elastic effect. Nevertheless, the obtained results with relative slow gather frequency in this work may not seriously affect the detection of impact damage and characterization of impact damage types.

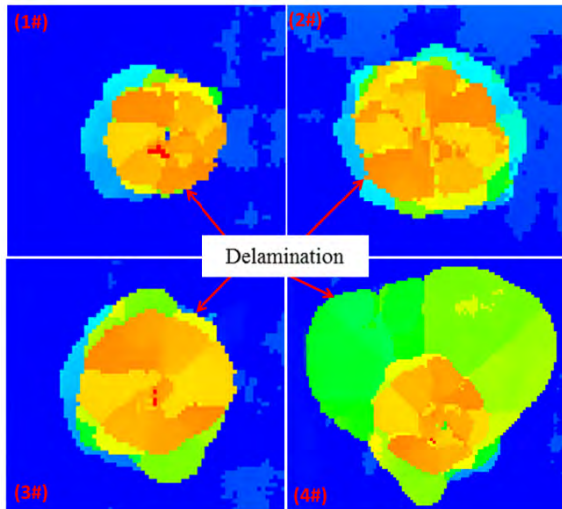
Fig. 10 shows the detection results of specimens 1#-4# using ultrasonic C-scanning, in which the delamination in the same sub-layer is displayed with the same color. From Fig. 10, we can find that there is delamination in each sub-layer and the area of delamination increases with increase of impact energy. Additionally, the delamination in each sub-layer shows the peanut shape, which is consistent with the results in [33]. Actually, the detection results of ultrasonic C-scanning show the superposition of delamination in each

FIGURE 10. The detection results of specimen 1#~4# using ultrasonic C-scanning.

sub-layer, thus, the delamination presents as a whole the irregular block shape.

Similarly, according to the step 5 in section III-B, the specimens are detected using SEM and ultrasonic C-scanning respectively and the corresponding partial results are shown in Fig. 9 and Fig. 10.
