Characteristics of Partial Discharge on 10 kV Covered Conductor Around Tower Head

INDEX TERMS Covered conductor, distribution network tower head, impulse current characteristic, partial discharge.

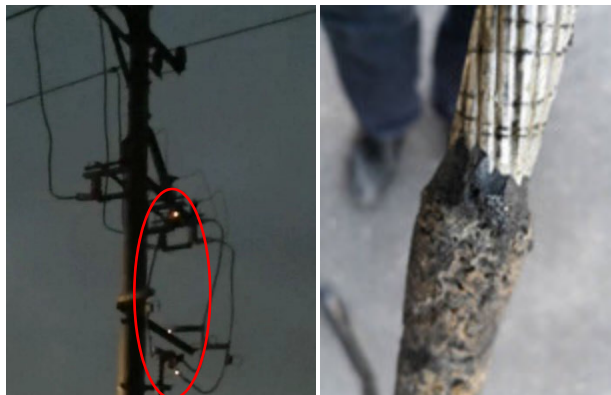
FIGURE 1. Partial discharge problem and burned insulation on covered conductor in Coastal areas.

Figure 1 comes from the maintenance team of power company in Fujian Province. Figure 2 comes from the maintenance team of power company in Beijing City and Anhui Province.

Among them, Zhangzhou and Dalian are coastal cities with high pollution level. The burning of conductor insulation is serious and causes high risk of flashover. In addition, discharge arcs can melt XLPE insulation material. XLPE will drop to the ground and may trigger a fire [5]. The distribution network reliability and safety are affected dramatically. In other inland cities, the degree of covered conductor damages is relatively lower. However, the risk of earth fault and fire still cannot be neglected. According to statistical data of Liaoning power supply recovery, the average recovery time of covered conductor failures exceeds 38 hours [7]. Operation and Maintenance team spent plenty of time on locating the earth point. As showed in figure 2, damaged insulation is usually covered by binding wire [9]. Without proper inspection devices, this damage is hardly to find.

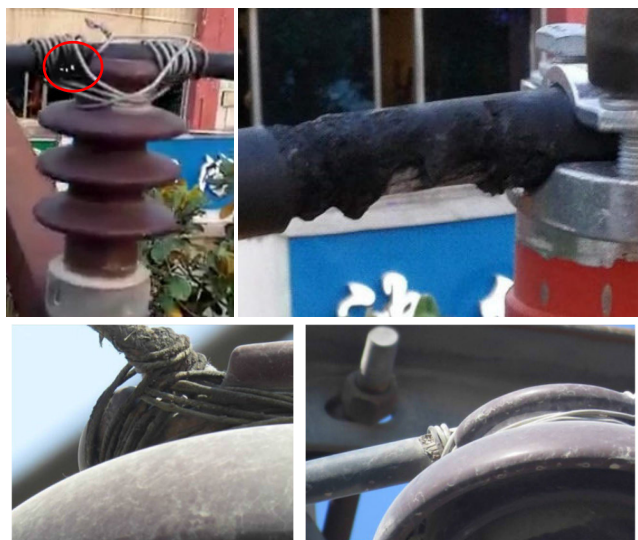
FIGURE 2. Partial discharge problem and burned insulation on covered conductor in Inland areas.

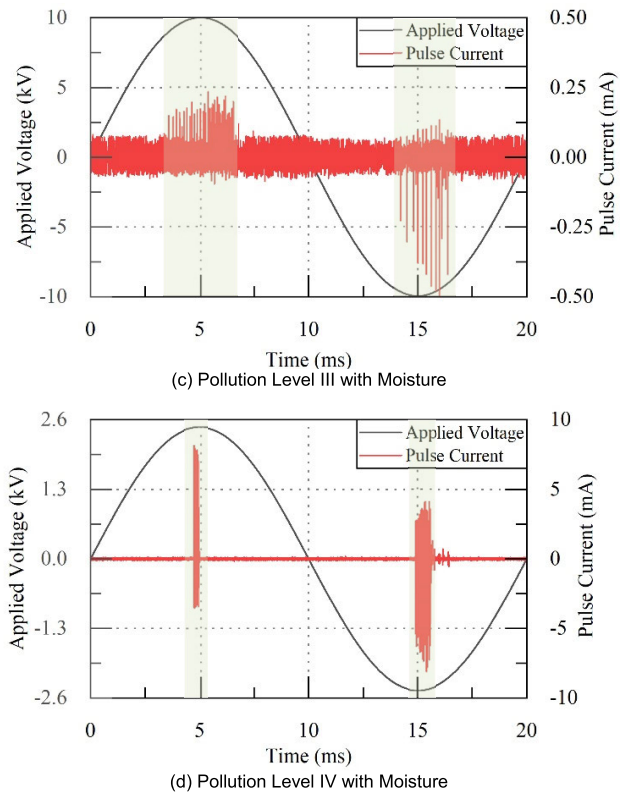
FIGURE 10. PD waveform of damaged covered conductor insulation under binding wire.

Figure 10 illustrates the waveform of pulse current and applied voltage when covered conductor insulation is damaged under binding wire. It shows that different pollution levels cannot change the phase of partial discharge.

- c. The fingerprint of PRPD. According to figure 9 and figure 10, there are two different types of phase distribution. This fingerprint can be used to judge whether the covered conductor insulation under binding wire is intact.

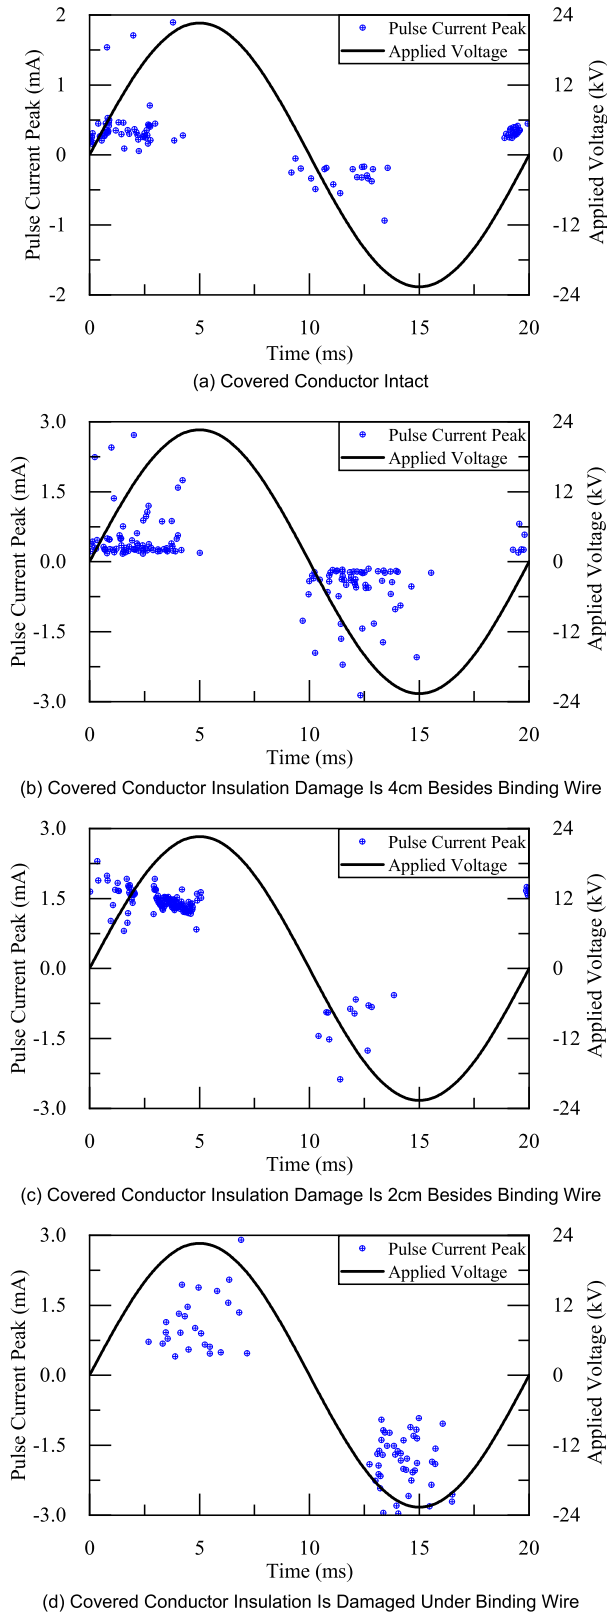
FIGURE 11. PRPD pattern of pollution Level III and moisture with 16kV applied voltage.

Figure 11 illustrates the Phase Resolved Partial Discharge (PRPD) of level III pollution with moisture. It is clearly to see that the PRPD patterns can be divided into two cases: pulse currents occur around the peak area of applied voltage or after

the zero-crossing point of applied voltage. Meanwhile, PRPD patterns of other pollution levels also follows the same rule. These results demonstrate that the phase distribution of partial

discharge will not change with pollution level. These can help us to classify the partial discharge type happened in covered conductor system.

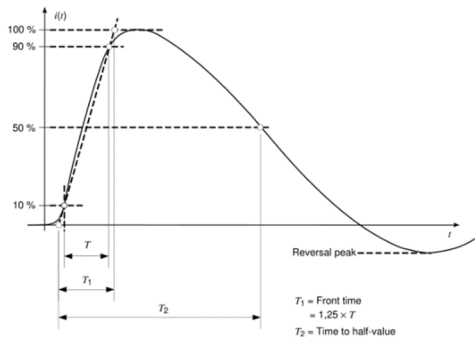
FIGURE 13. Pulse current parameter definitions in IEC standard.

Standard IEC-62475 has stipulated related evaluation methods of the bi-exponential shape pulse current as showed in figure 13. This paper will use amplitude, front time T_1 , and tail time T_2 to describe a single partial discharge pulse current.

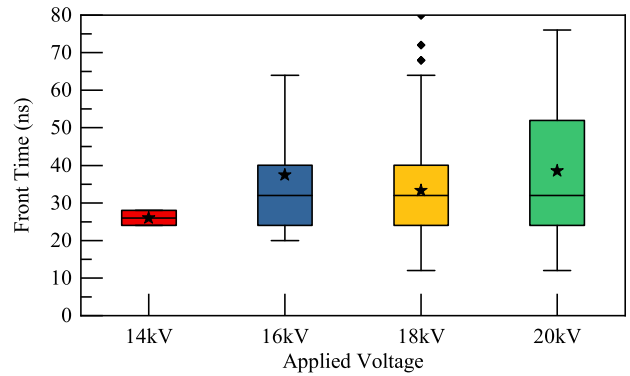
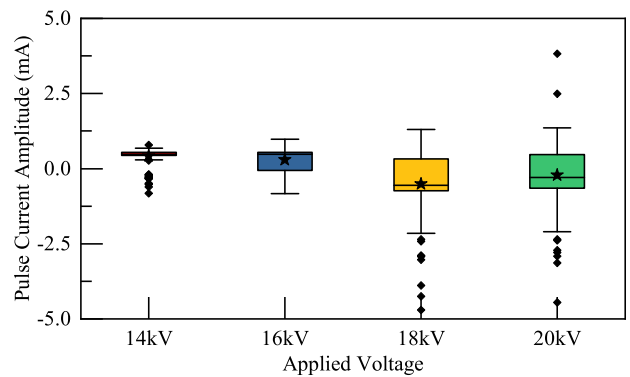
FIGURE 14. Pulse current parameters with intact covered conductor and Level III moist pollution.

Table 4 shows the ranges of front time, tail time and amplitude in different working conditions. Figure 14 and 15 show the boxplot of changing of front time, tail time and amplitude with different applied voltages. According to test results, following rules can be revealed with the condition of pollution and moisture on equipment surface.

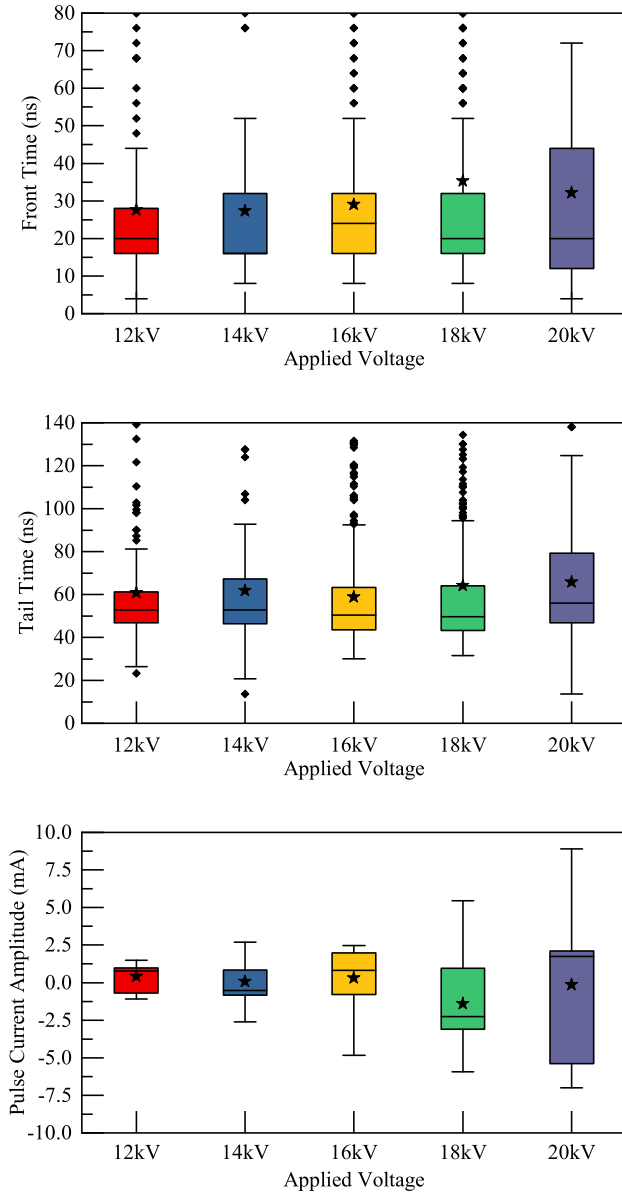
FIGURE 15. Pulse current parameters with covered Fig. 1. Conductor damage under binding wire and Level III moist pollution.

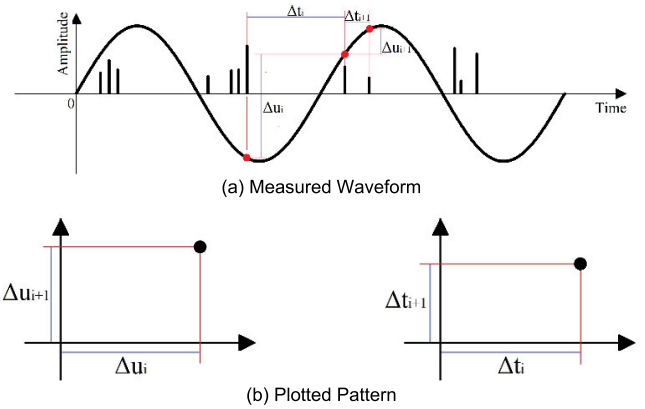
FIGURE 16. Definition of Δu and Δt patterns.

CIGRE proposes more than 20 types of PD patterns, and $\Delta u/\Delta t$ is one of them. The relationship between space charge and electric field can be describe by Δu pattern, while Δt pattern can be used to the dissipation information of space charge [28]. Figure 16 shows the definition of the patterns. In the plotted pattern, each dot represents a partial discharge while its position represents the relationship between its last and next discharge. In Δu pattern, dots near X-axis mean the applied voltage is almost the same in its next discharges while a dot near Y-axis means the applied voltage is almost the same in the last discharges. In Δt pattern, the rule is the same except applied voltage becomes time interval of discharges. Therefore, if a dot is near original point, the discharges are continuous and dense. This pattern can be used for status evaluation by describing dot distributions with numerical parameters. For example, using neural networks to identify different shapes. However, fulfilling status evaluation is the next step of our research. Therefore, this paper analyzed the shape of dots manually and extracted the average values of Δt and Δu .

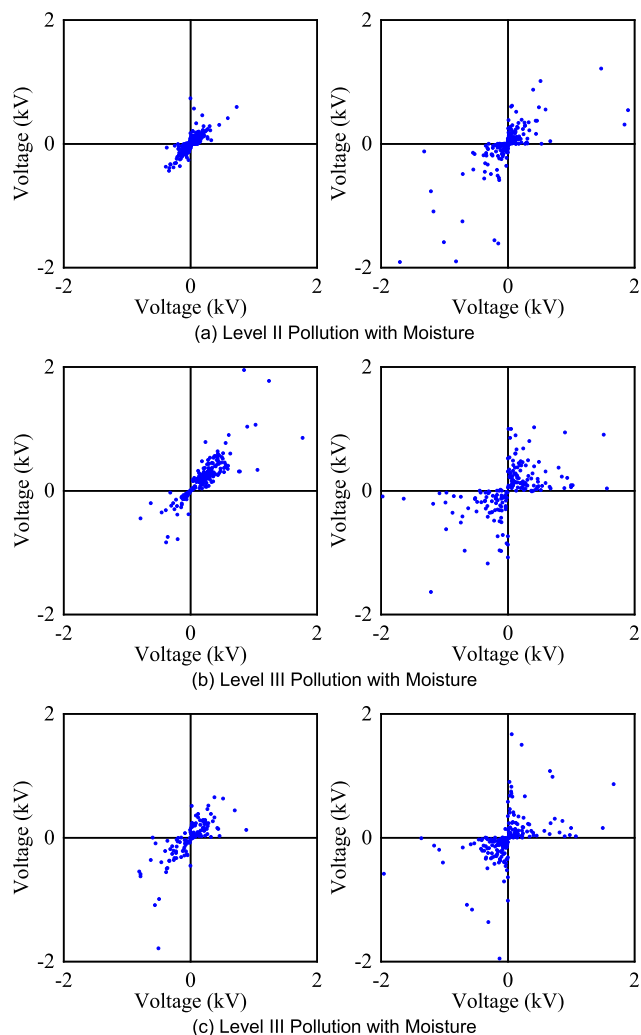
FIGURE 17. Δu pattern of different working conditions (Left: Covered conductor is damaged under binding wire; Right: Covered conductor is intact under binding wire.)

Left three pictures represent the condition of damaged covered conductor insulation under bidding wire. In these patterns, most values of Δu dots are below 1kV. The dots are distributed diagonally in the first and third quadrants, and symmetrical to the origin. With the decreasing of pollution level, the dots in Δu pattern gradually converge towards the origin. In other words, the slope of applied voltage is relatively low when the partial discharge happens. The low slope area is around the peak of voltage waveform. The average values of Δu in level II, III and IV pollutions are 0.11kV, 0.68kV and 1.45kV respectively.

Right three pictures represent the condition of intact covered conductor insulation under bidding wire. In these patterns, the value of Δu varies greatly with the range of 0kV to 3kV. But most of them are still below 1kV. The dots are fan-shaped distributed in the x-axis, y-axis, first quadrants, and third quadrants. They are also symmetrical to the origin. However, with the decreasing of pollution level, the dots in Δu pattern do not gradually converge towards the origin. The average values of Δu are between 0.2kV to 0.5kV.

Figure 17 shows Δu pattern of different working conditions.

According to the definition of the pattern, it can be known that the first quadrant in the Δu pattern represents the partial discharge occurs in the rising period of the applied voltage, and the third quadrant represents the partial discharge occurs during the falling period of the applied voltage. As all patterns are symmetrical to the origin, it shows that the distribution of partial discharge pulses is similar in positive and negative polarities under different working conditions. In addition, when covered conductor insulation is intact under bidding wire, the values of Δu are higher than damaged case. This represents the partial discharge is distributed more widely in a power frequency period.

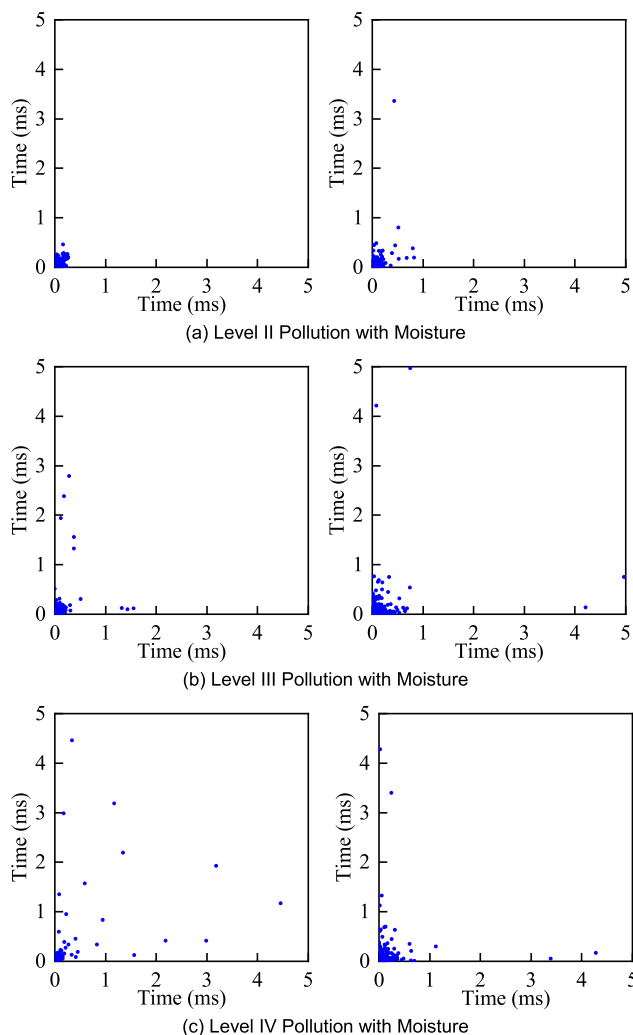
FIGURE 18. Δt pattern of different working conditions (Left: Covered conductor is damage under binding wire; Right: Covered conductor is intact under binding wire.)

Figure 18 shows Δt pattern of different working conditions.

Compare two different insulation status in figure 18, the dots are more gathered around the origin when the covered conductor insulation is intact under binding wire. In other words, the partial discharges happen more intensely. In the view of microscopic analysis, the result shows that the retention charges from partial discharge can be rapidly conducted and released through uncovered conductor if the covered conductor insulation is damaged under binding wire. This results in the weakening of the reverse superposition effect of the electric field generated by charges, so the next partial discharge can occur more quickly. On the contrary, if the covered conductor insulation is intact, the charges formed by partial discharge do not have a fast release path. Therefore, their residence effect is stronger and the dissipation speed is slower. Finally, the reverse superposition effect of the electric field causes the time interval between two partial discharges to increase.
